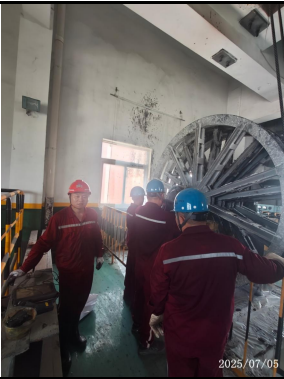
| 34 | GX-B1310/21-2-25162 | 2025/8/11 | 符合标准要求。 | <p>2025/07/05</p> |

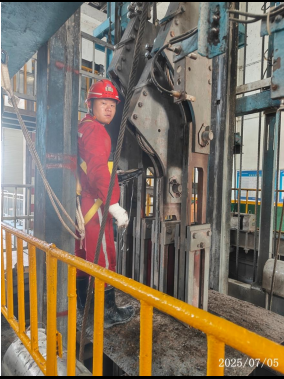
| 35 | GX-B1310/21-2-25163 | 2025/8/11 | 符合标准要求。 | <p>2025/07/05</p> |

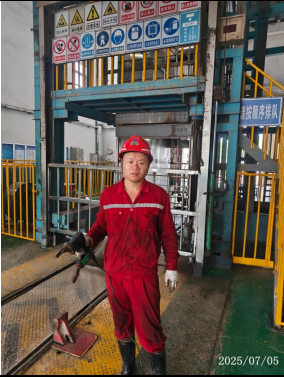
| 36 | GX-B1427/21-2-25163 | 2025/8/11 | 符合标准要求。 | <p>2025/07/05</p> |

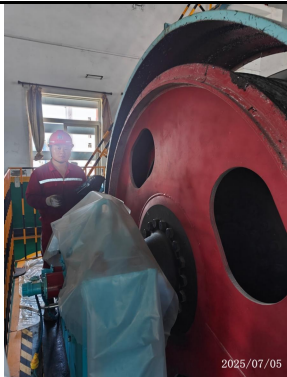
| 37 | GX-B1310/21-2-25164 | 2025/8/11 | 符合标准要求。 | |

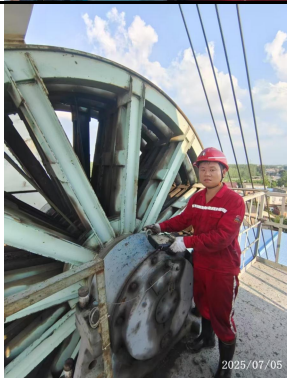
| 38 | GX-B1310/21-2-25165 | 2025/8/11 | 符合标准要求。 | |

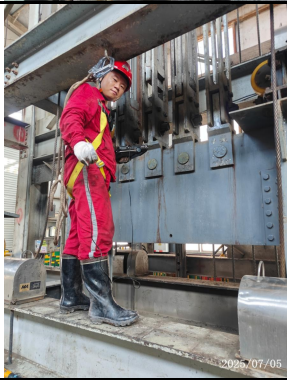
| 39 | GX-B1310/21-2-25166 | 2025/8/11 | 符合标准要求。 | |

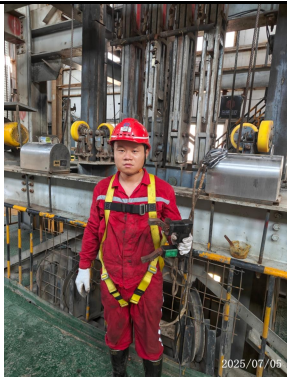
| 40 | GX-B1427/21-2-25166 | 2025/8/11 | 符合标准要求。 | | |

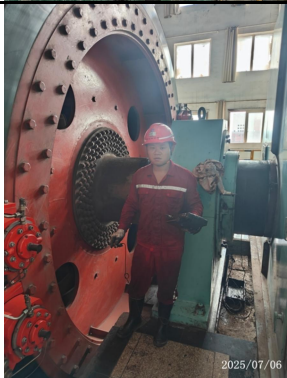
| 41 | GX-B1310/21-2-25167 | 2025/8/11 | 符合标准要求。 | | |

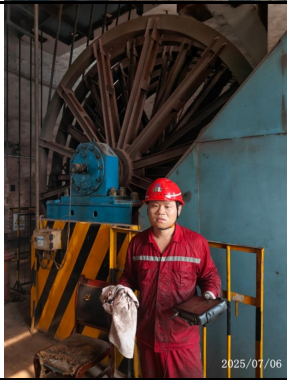
| 42 | GX-B1310/21-2-25168 | 2025/8/11 | 符合标准要求。 | | |

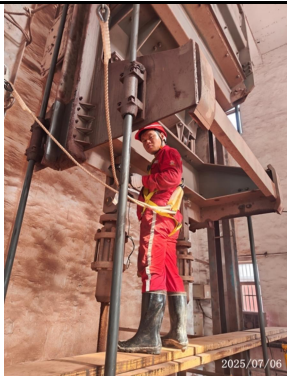
| 43 | GX-B1310/21-2-25169 | 2025/8/11 | 符合标准要求。 | |

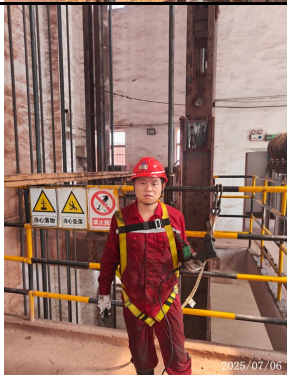
| 44 | GX-B1427/21-2-25169 | 2025/8/11 | 符合标准要求。 | |

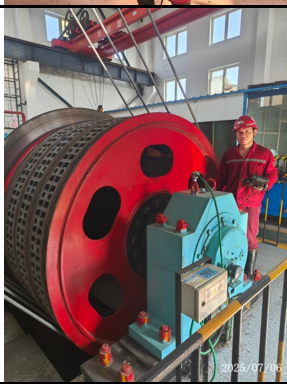
| 45 | GX-B1310/21-2-25170 | 2025/8/11 | 符合标准要求。 | |

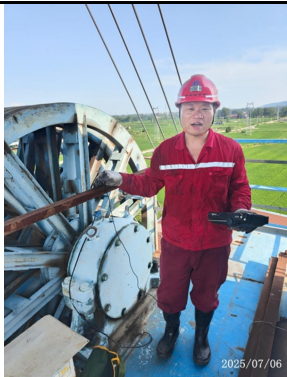
| 46 | GX-B1310/21-2-25171 | 2025/8/11 | 符合标准要求。 | |

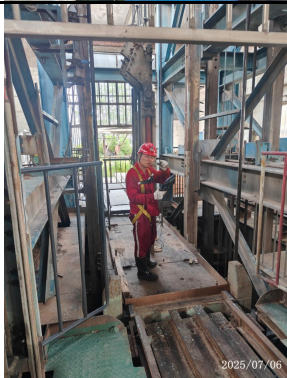
| 47 | GX-B1310/21-2-25172 | 2025/8/11 | 符合标准要求。 | |

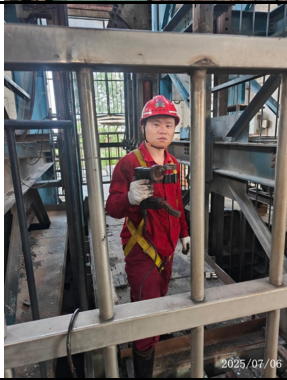
| 48 | GX-B1427/21-2-25172 | 2025/8/11 | 符合标准要求。 | |

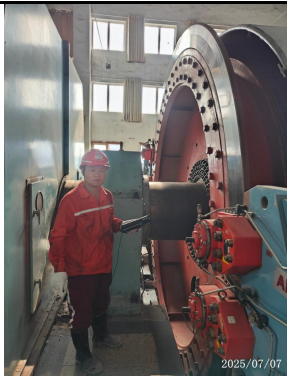
| 49 | GX-B1310/21-2-25173 | 2025/8/11 | 符合标准要求。 | |

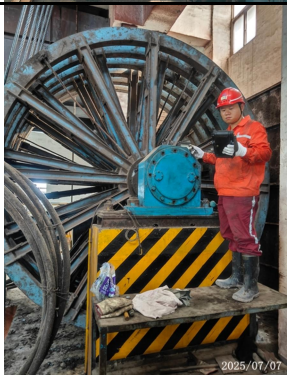
| 50 | GX-B1310/21-2-25174 | 2025/8/11 | 符合标准要求。 | |

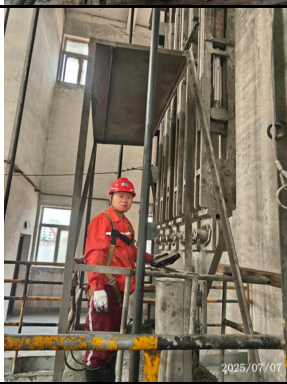
| 51 | GX-B1310/21-2-25175 | 2025/8/11 | 符合标准要求。 | |

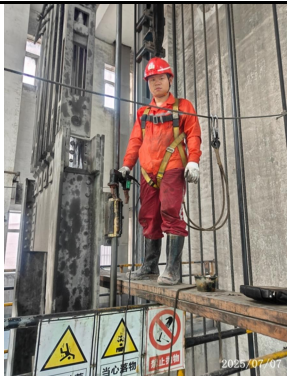
| 52 | GX-B1427/21-2-25175 | 2025/8/11 | 符合标准要求。 | |

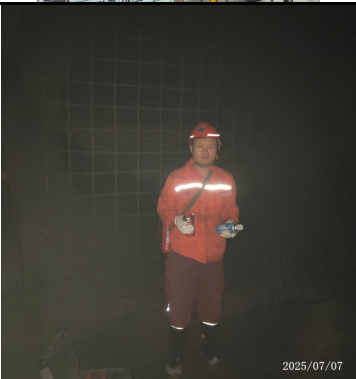
| 53 | GX-B1428/21-2-25176 | 2025/8/11 | 无缺陷迹痕显示。 | |

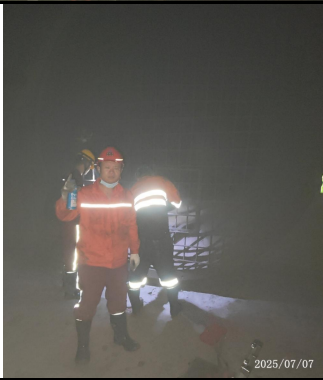
| 54 | GX-B1428/21-2-25177 | 2025/8/11 | 无缺陷迹痕显示。 | |

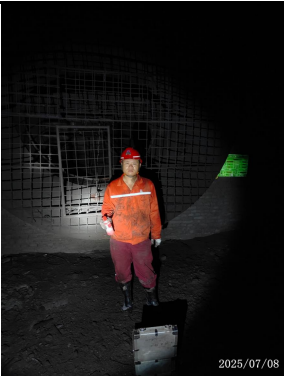
| 55 | GX-B1428/21-2-25178 | 2025/8/11 | 无缺陷迹痕显示。 | | | |

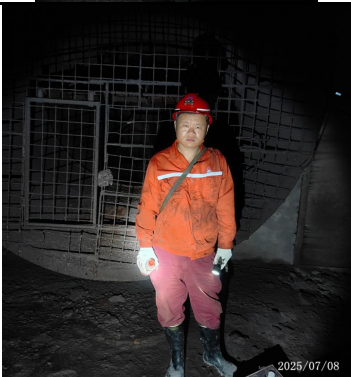
| 56 | GX-B1428/21-2-25179 | 2025/8/11 | 无缺陷迹痕显示。 | | | |

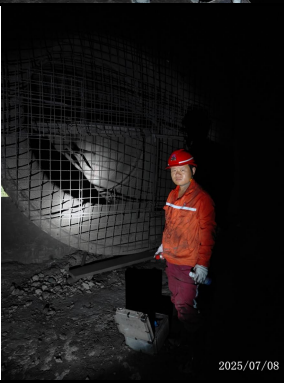
| 57 | GX-B1428/21-2-25180 | 2025/8/11 | 无缺陷迹痕显示。 | | | |

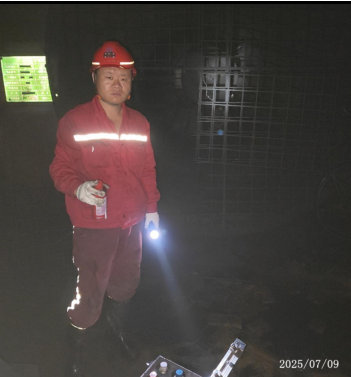
| 58 | GX-B1428/21-2-25181 | 2025/8/11 | 无缺陷迹痕显示。 | |

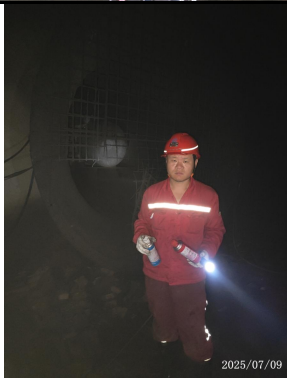
| 59 | GX-B1428/21-2-25182 | 2025/8/11 | 无缺陷迹痕显示。 | |

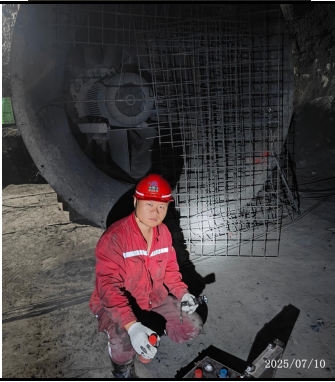
| 60 | GX-B1428/21-2-25183 | 2025/8/11 | 无缺陷迹痕显示。 | |

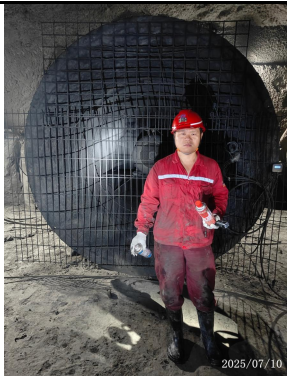
| 61 | GX-B1428/21-2-25184 | 2025/8/11 | 无缺陷迹痕显示。 | | |

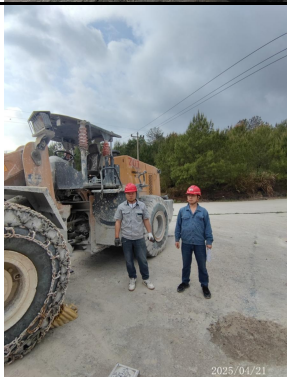
| 62 | GX-B1539/22-2-25028 | 2025/8/11 | 除无辅助制动系统，其余所检项目合格。 | | |

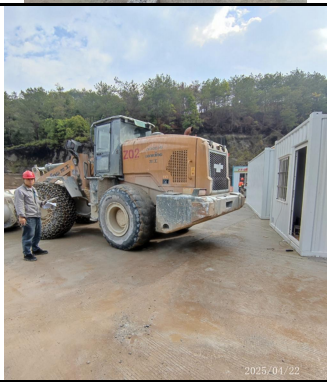
| 63 | GX-B1539/22-2-25029 | 2025/8/11 | 除无辅助制动系统，其余所检项目合格。 | | |

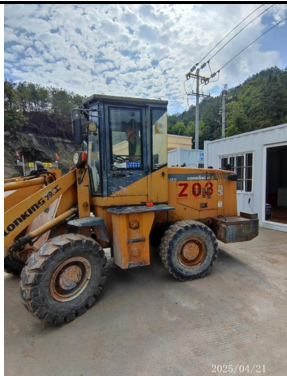
| 64 | GX-B1539/22-2-25030 | 2025/8/11 | 除无辅助制动系统，其余所检项目合格。 | |

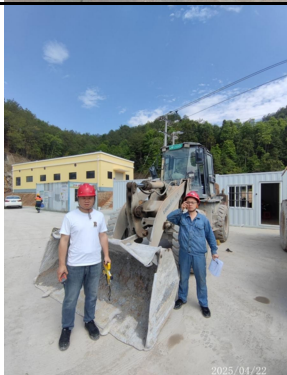
| 65 | GX-B1539/22-2-25031 | 2025/8/11 | 除无辅助制动系统，其余所检项目合格。 | |

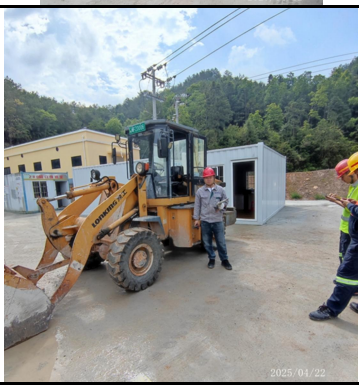
| 66 | GX-B1539/22-2-25032 | 2025/8/11 | 除无辅助制动系统、坐姿司机室基本出入口高度小于1300mm，其余所检项目合格。 | |

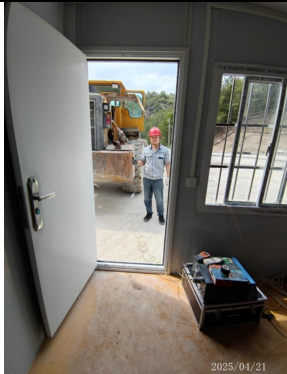
| 67 | GX-B1539/22-2-25033 | 2025/8/11 | 除无辅助制动系统、坐姿司机室基本出入口高度小于1300mm，其余所检项目合格。 | | <br>2025/04/21 |

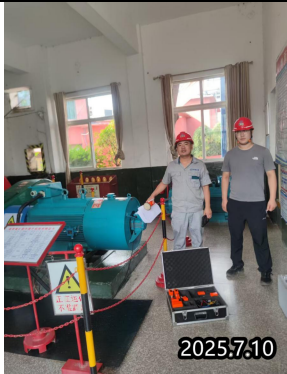
| 68 | GX-B1302/25-2-25002 | 2025. 8. 12 | 综合判定：合格。 | | <br>2025/7/10 |

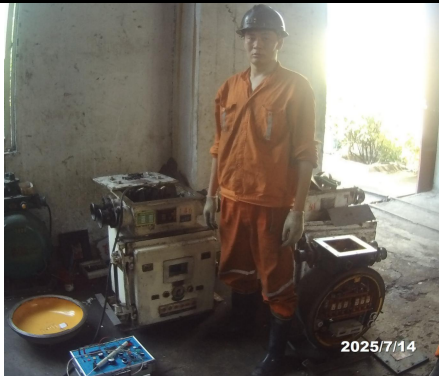
| 69 | GX-B1359/21-2-25023~25024 | 2025. 8. 12 | 本次共检矿用隔爆型照明信号综合保护装置2台,2台所检项目合格。 | | <br>2025/7/14 |

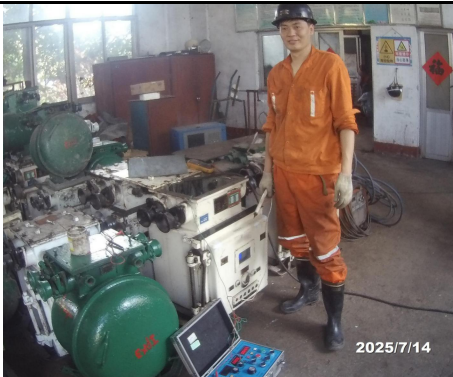
| 70 | GX-B1352/21-2-25148~25150 | 2025. 8. 12 | 本次共检矿用防爆低压交流真空馈电开关3台, 3台所检项目合格。 | |

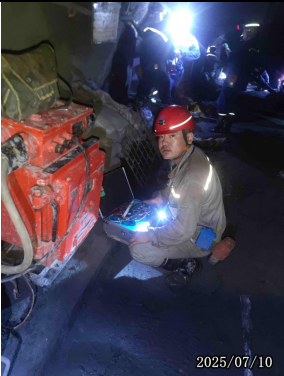
| 95 | GX-B1352/21-2-25151~25153 | 2025. 8. 12 | 本次共检矿用防爆低压交流真空馈电开关3台, 3台所检项目合格。 | | |

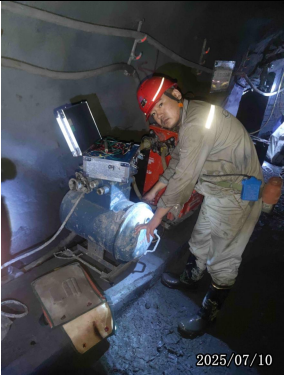
| 96 | GX-B1359/21-2-25025 | 2025. 8. 12 | 所检项目合格。 | | |

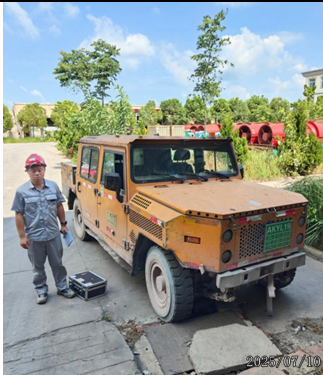
| 97 | GX-B1612/23-2-25127 | 2025. 8. 12 | 所检项目合格。 | |

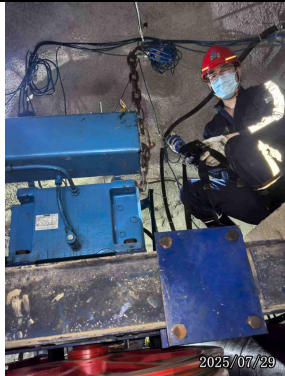
| 98 | GX-B1310/21-2-25194 | 2025. 8. 11 | 符合标准要求。 | |

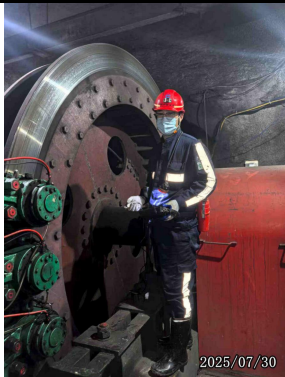
| 99 | GX-B1310/21-2-25195 | 2025. 8. 11 | 符合标准要求。 | |
