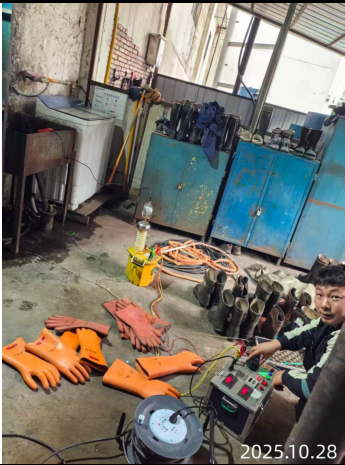
| 序号 | 报告编号 | 发布日期 | 结论 | 影像资料 |
|---|---|---|---|---|
| 1 | GX-B1328/25-3-25260 | 2025. 11. 3 | 所检项目合格。 | |

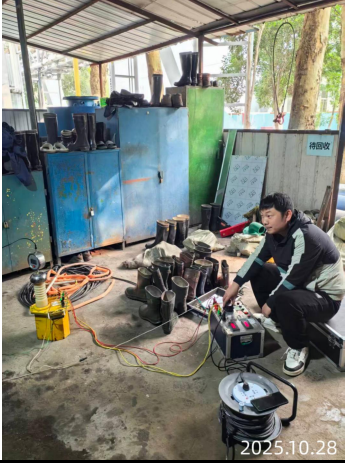
| 序号 | 报告编号 | 发布日期 | 结论 | 影像资料 |
|---|---|---|---|---|
| 2 | GX-B1328/25-3-25261 | 2025. 11. 3 | 所检项目合格。 | |

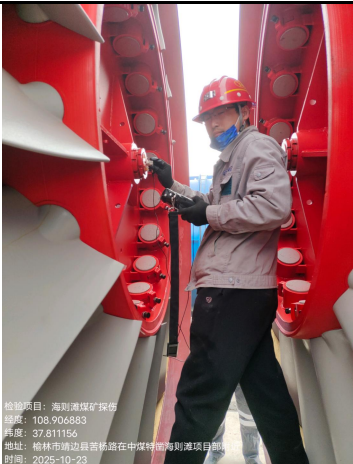
| 3 | GX-B1310/21-3-25237 | 2025. 11. 7 | 未发现超过 $\Phi 2\text{mm}$ 当量直径的缺陷。 | <p>检验项目：海则滩煤矿探伤<br/>经度：108.906883<br/>纬度：37.611156<br/>地址：榆林市靖边县高杨路在中煤特能海则滩项目部<br/>时间：2025-10-23</p> |

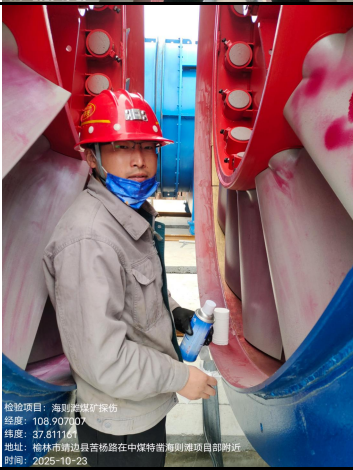
| 4 | GX-B1428/21-3-25068 | 2025. 11. 7 | 无缺陷迹痕显示。 | <p>检验项目：海则滩煤矿探伤<br/>经度：108.907007<br/>纬度：37.611161<br/>地址：榆林市靖边县高杨路在中煤特能海则滩项目部附近<br/>时间：2025-10-23</p> |

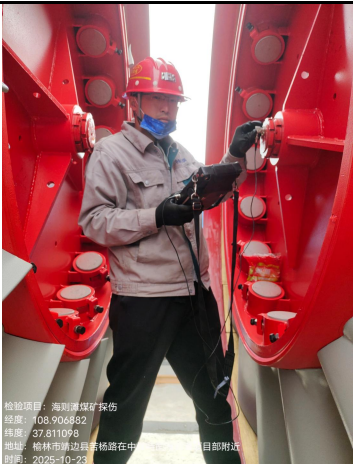
| 5 | GX-B1310/21-3-25238 | 2025. 11. 7 | 未发现超过 $\Phi 2\text{mm}$ 当量直径的缺陷。 | <p>检验项目: 海阳港煤矿探伤<br/>经度: 108.906882<br/>纬度: 37.811098<br/>地址: 榆林市靖边县杨路在中煤特能海阳项目部附近<br/>时间: 2025-10-23</p> |

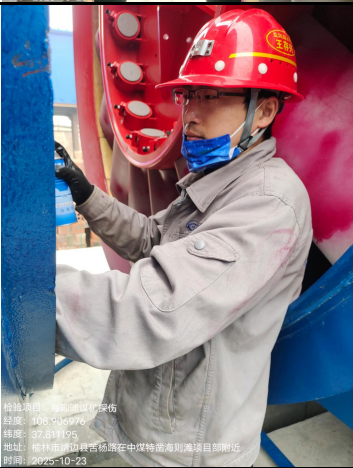
| 6 | GX-B1428/21-3-25069 | 2025. 11. 7 | 无缺陷迹痕显示。 | <p>检验项目: 海阳港煤矿探伤<br/>经度: 108.906882<br/>纬度: 37.811098<br/>地址: 榆林市靖边县杨路在中煤特能海阳项目部附近<br/>时间: 2025-10-23</p> |

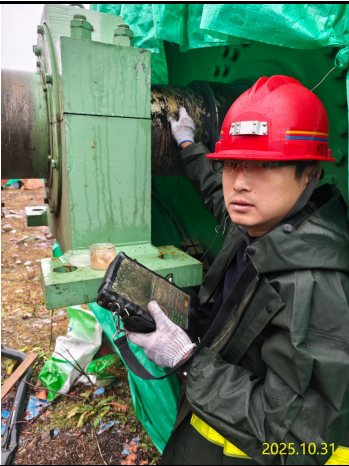
| 7 | GX-B1310/21-3- 25239 | 2025年11月7日 | 符合标准要求。 | |

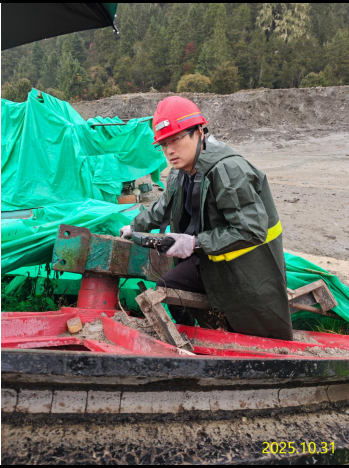
| 8 | GX-B1310/21-3- 25240 | 2025年11月7日 | 符合标准要求。 | |

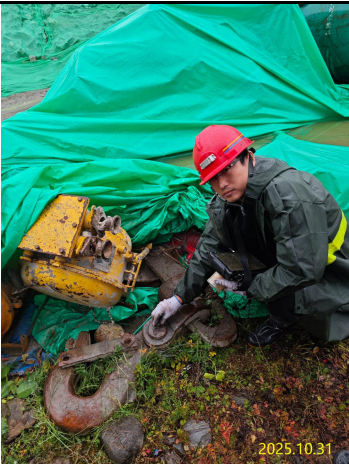
| 9 | GX-B1310/21-3- 25241 | 2025年11月7日 | 符合标准要求。 | |

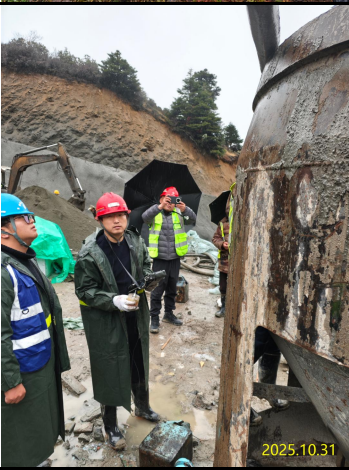
| 10 | GX-B1310/21-3- 25242 | 2025年11月7日 | 符合标准要求。 | |

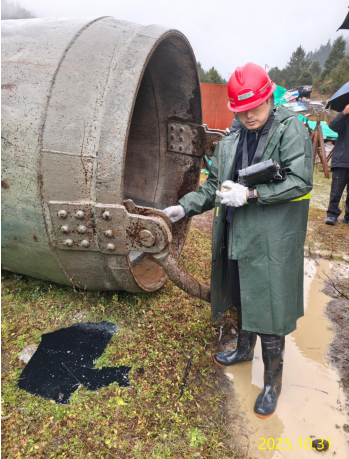
| 11 | GX-B1310/21-3- 25243 | 2025年11月7日 | 符合标准要求。 | A worker wearing a green raincoat, red helmet, and white gloves is inspecting a large, horizontal metal pipe. The pipe has a circular opening with a flange. The worker is holding a device, possibly a detector or a camera. The ground is muddy and there is some debris. A yellow timestamp "2025.10.31" is visible in the bottom right corner of the image. |

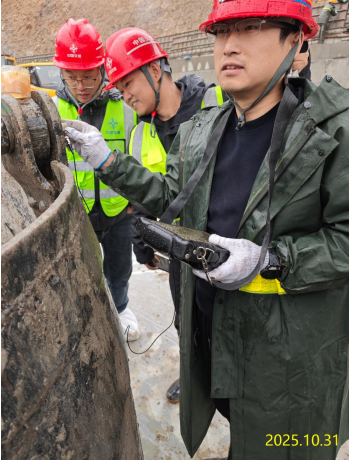
| 12 | GX-B1310/21-3- 25244 | 2025年11月7日 | 符合标准要求。 | Three workers wearing green raincoats, red helmets, and white gloves are inspecting a large, vertical metal pipe. The worker in the foreground is holding a device, possibly a detector or a camera. The other two workers are standing behind him, also looking at the pipe. The ground is muddy and there is some debris. A yellow timestamp "2025.10.31" is visible in the bottom right corner of the image. |
