序号	报告编号	发布日期	结论	影像资料	
35	GX-B1328/25-2-25139	2025. 11. 20	本次共检验电器1只， 1支验电器合格。		 
36	GX-B1323/21-2-25078~25094	2025. 11. 20	所检项目合格。

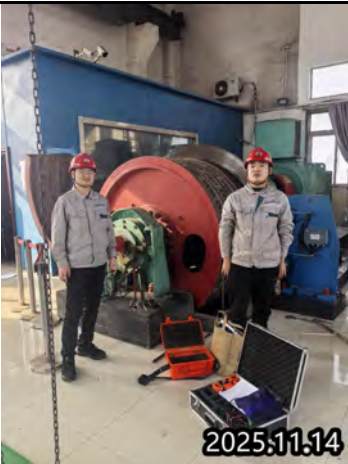
41	GX-B1301/25-2-25026	2025/11/21	综合判定:合格。

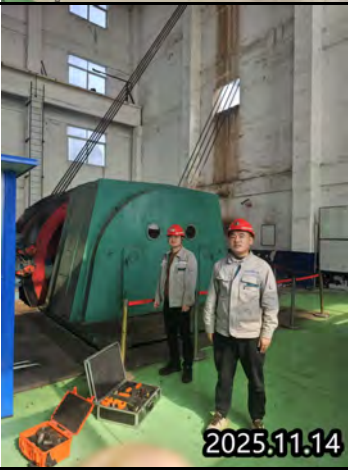
42	GX-B1301/25-2-25027	2025/11/21	综合判定:合格。

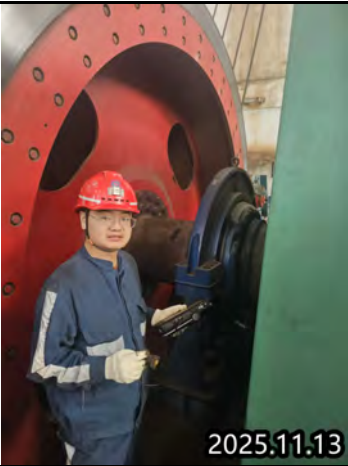
43	GX-B1310/21-2-25441	2025/11/21	符合标准要求。

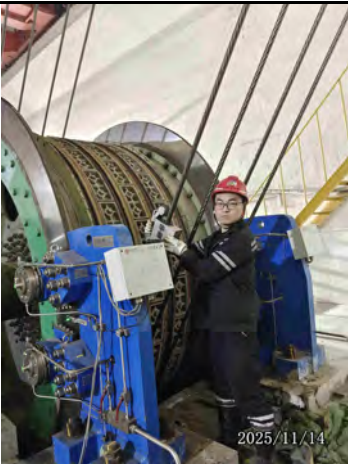
105	GX-B1598/24-2-25250	2025/11/23	实测钢丝绳有效截面积损失百分比最大为1.56%，小于5%为正常。

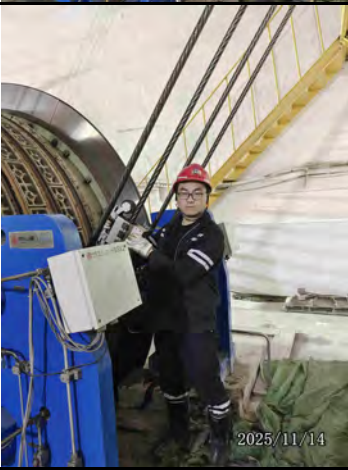
106	GX-B1598/24-2-25251	2025/11/23	实测钢丝绳有效截面积损失百分比最大为1.72%，小于5%为正常。

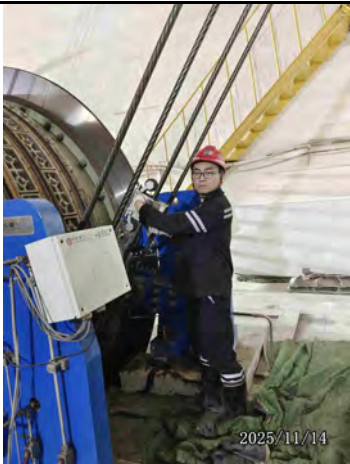
107	GX-B1598/24-2-25252	2025/11/23	实测钢丝绳有效截面积损失百分比最大为1.80%，小于5%为正常。

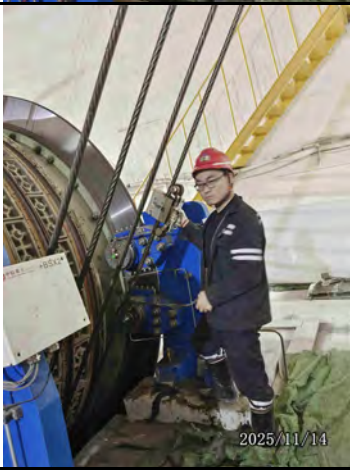
108	GX-B1598/24-2-25253	2025/11/23	实测钢丝绳有效截面积损失百分比最大为1.77%，小于5%为正常。

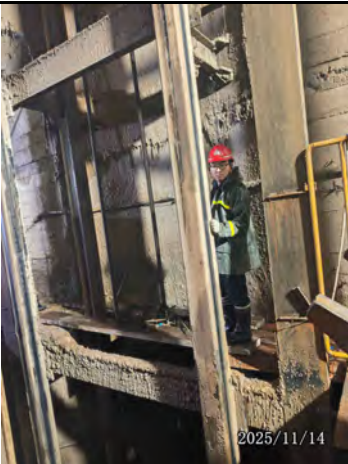
109	GX-B1598/24-2-25254	2025/11/23	实测钢丝绳有效截面积损失百分比最大为1.92%，小于5%为正常。

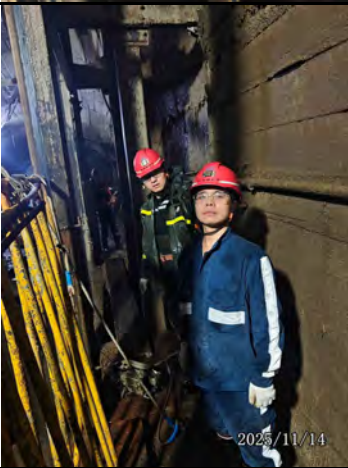
110	GX-B1598/24-2-25255	2025/11/23	实测钢丝绳有效截面积损失百分比最大为1.85%，小于5%为正常。

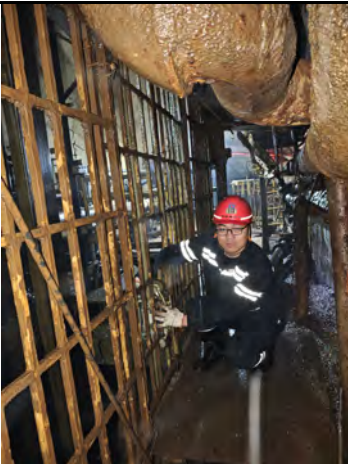
111	GX-B1598/24-2-25256	2025/11/23	实测钢丝绳有效截面积损失百分比最大为0.49%，小于5%为正常。

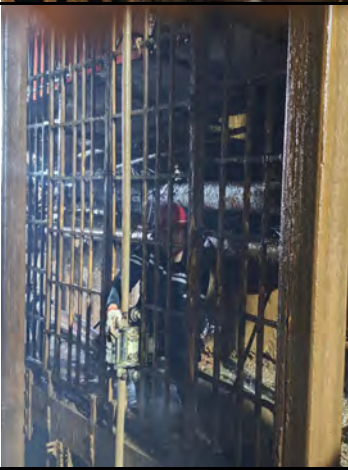
112	GX-B1598/24-2-25257	2025/11/23	实测钢丝绳有效截面积损失百分比最大为0.40%，小于5%为正常。

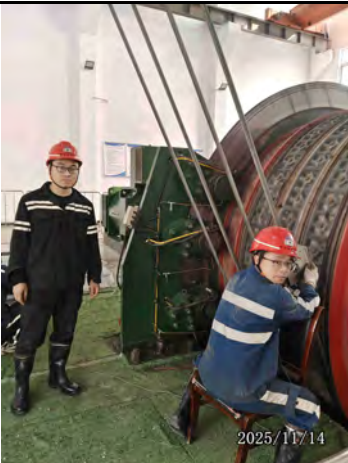
113	GX-B1598/24-2-25258	2025/11/23	实测钢丝绳有效截面积损失百分比最大为2.18%，小于5%为正常。
