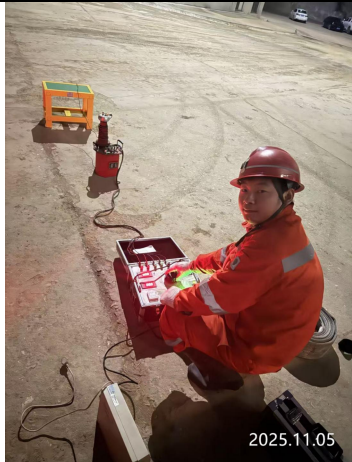
78	GX-B1328/20-3-25271	2025年11月27日	本次共检绝缘台3套，3套绝缘台所检项目合格。

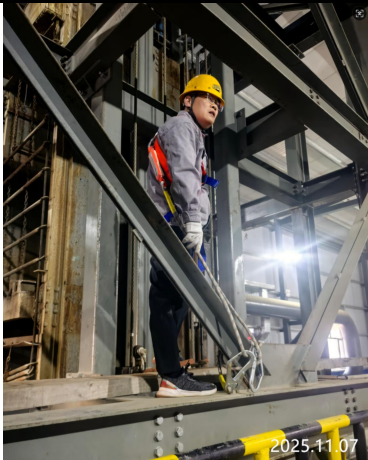
79	GX-B1328/25-3-25276	2025年11月27日	本次共检绝缘手套44只，44只绝缘手套合格。	
80	GX-B1328/25-3-25277	2025年11月27日	本次共检绝缘靴44只，44只绝缘靴合格。	
81	GX-B1598/24-3-25017	2025年11月27日	实测钢丝绳有效截面积损失百分比最大为1.58%，小于5%为正常。

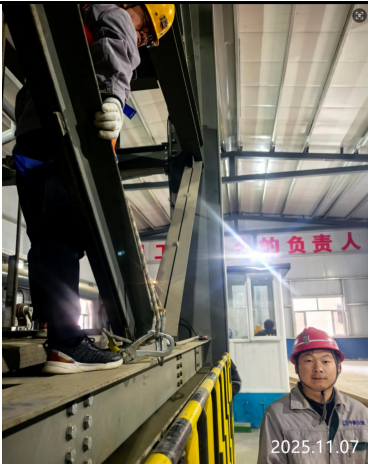
82	GX-B1598/24-3-25018	2025年11月27日	实测钢丝绳有效截面积损失百分比最大为1.76%，小于5%为正常。

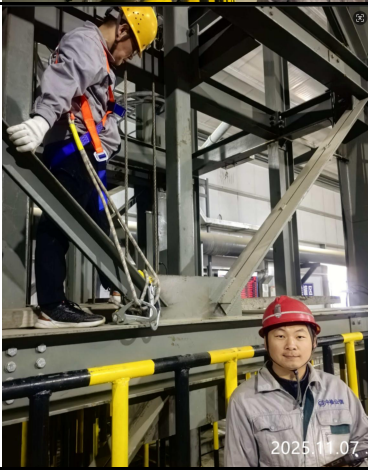
83	GX-B1598/24-3-25019	2025年11月27日	实测钢丝绳有效截面积损失百分比最大为1.58%，小于5%为正常。

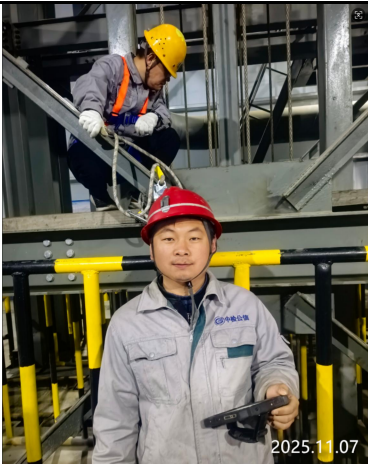
84	GX-B1598/24-3-25020	2025年11月27日	实测钢丝绳有效截面积损失百分比最大为1.98%，小于5%为正常。

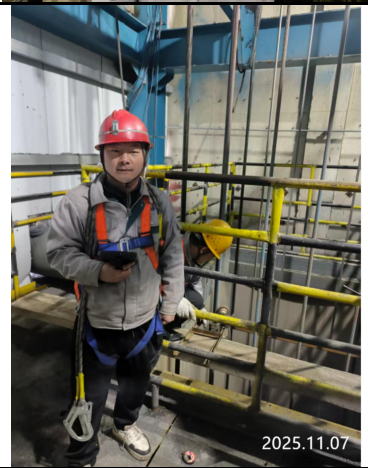
85	GX-B1598/24-3-25021	2025年11月27日	实测钢丝绳有效截面积损失百分比最大为1.95%，小于5%为正常。

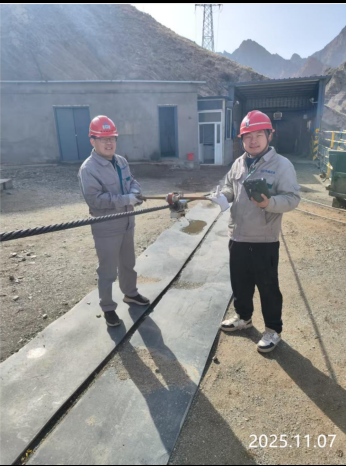
88	GX-B1598/24-3-25024	2025年11月27日	实测钢丝绳有效截面积损失百分比最大为1.94%，小于5%为正常。	  A photograph showing two workers in safety gear (hard hats, high-visibility vests) inspecting a cable in an industrial setting. The worker in the foreground is wearing a red hard hat and a grey jacket, holding a clipboard. The worker in the background is wearing a yellow hard hat and a grey jacket. The date 2025.11.07 is visible in the bottom right corner of the image.
89	GX-B1598/24-3-25025	2025年11月27日	实测钢丝绳有效截面积损失百分比最大为1.75%，小于5%为正常。
