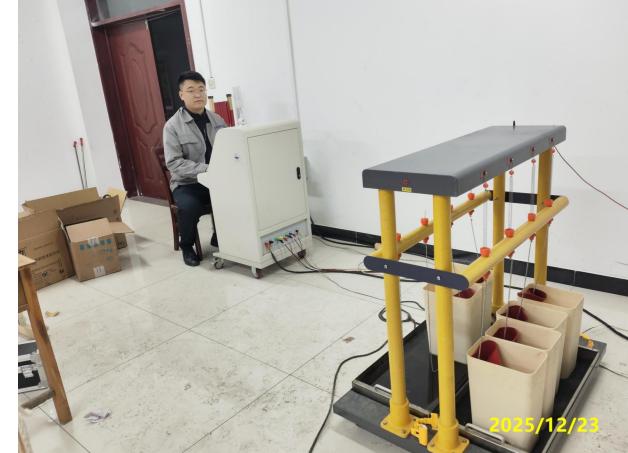
序号	报告编号	发布日期	结论	影像资料
98	GX-B1328/25-1-25161	2025.12.25	本次共检绝缘手套110只，110只绝缘手套合格。

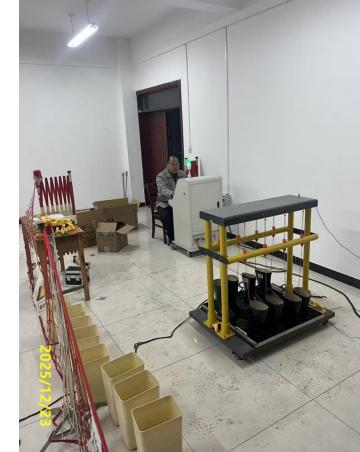
99	GX-B1328/25-1-25162	2025.12.25	本次共检绝缘靴100只，100只绝缘靴合格。

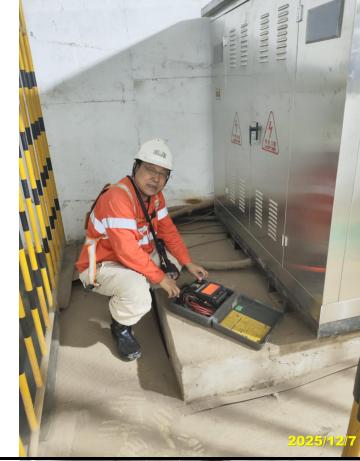
100	GX-B1313/21-1-25247~25250	2025.12.26	本次共检电力变压器4台，4台电力变压器所检项目合格

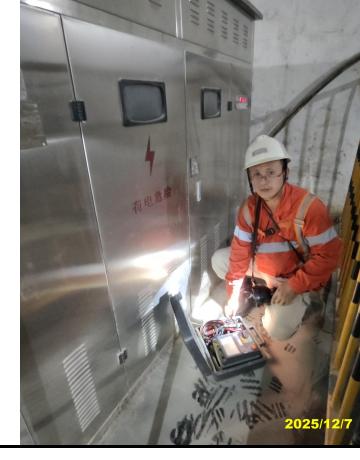
2025/12/7	
101	GX-B1313/21-1-25251~25253	2025.12.26	本次共检电力变压器3台，3台电力变压器所检项目合格

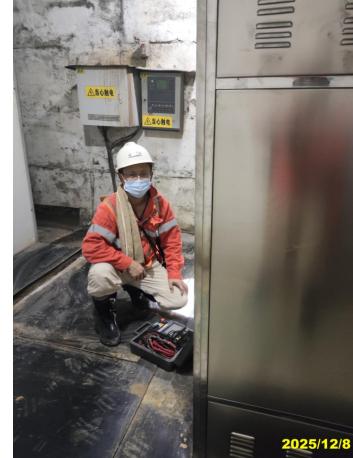
102	GX-B1313/21-1-25254~25258	2025.12.26	本次共检电力变压器5台，5台电力变压器所检项目合格

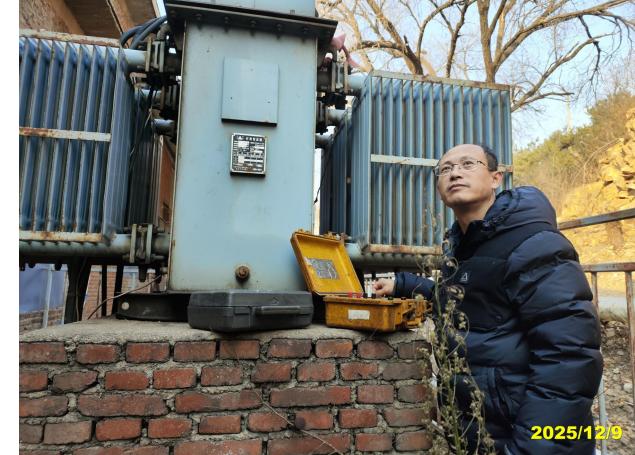
103	GX-B1313/21-1-25259~25262	2025.12.26	本次共检电力变压器4台，4台电力变压器所检项目合格

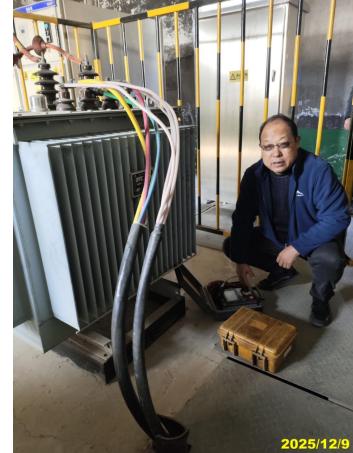
104	GX-B1313/21-1-25263~25264	2025.12.26	本次共检电力变压器2台，2台电力变压器所检项目合格

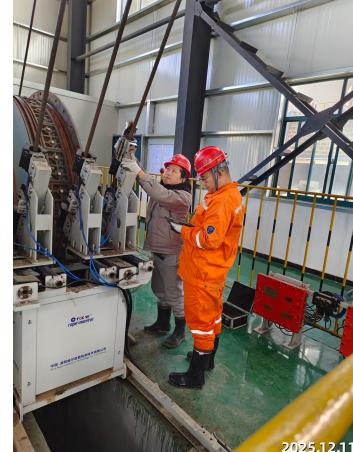
2025/12/9
105	GX-B1598/24-1-25110	2025.12.29	实测钢丝绳有效截面积损失百分比最大为1.95%，小于5%为正常

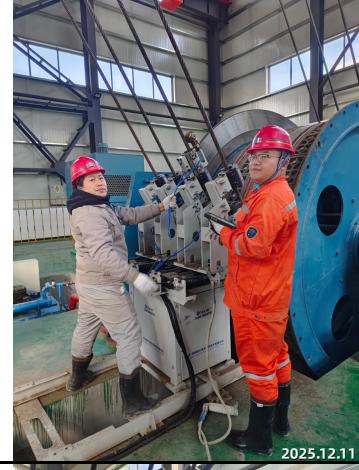
106	GX-B1598/24-1-25111	2025.12.29	实测钢丝绳有效截面积损失百分比最大为1.91%，小于5%为正常

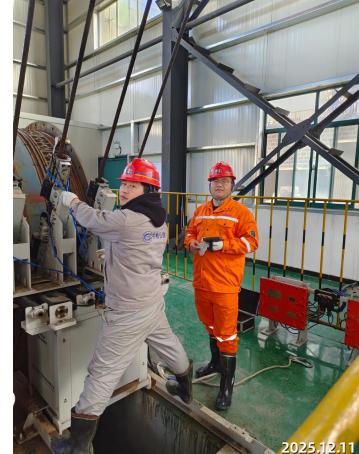
2025.12.11	
107	GX-B1598/24-1-25112	2025.12.29	实测钢丝绳有效截面积损失百分比最大2.09%，小于5%为正常

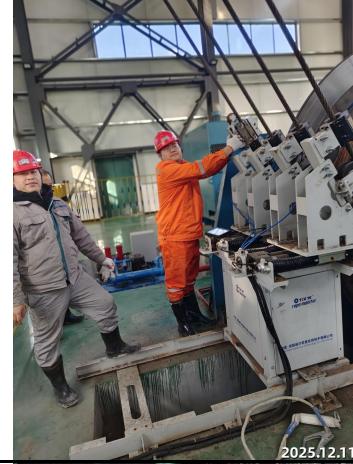
108	GX-B1598/24-1-25113	2025.12.29	实测钢丝绳有效截面 积损失百分比最大 1.77%，小于5%为正常

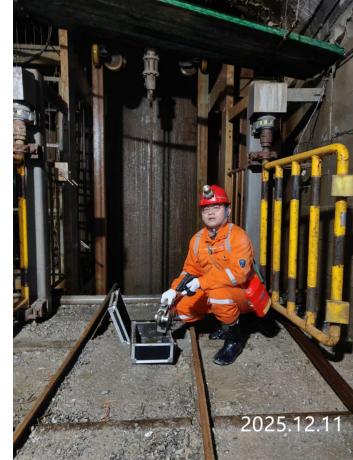
2025.12.11	
109	GX-B1598/24-1-25114	2025.12.29	实测钢丝绳有效截面 积损失百分比最大为 2.32%，小于5%为正常

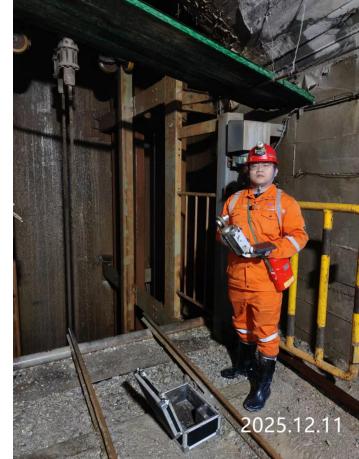
110	GX-B1598/24-1-25115	2025.12.29	实测钢丝绳有效截面 积损失百分比最大为 2.35%，小于5%为正常

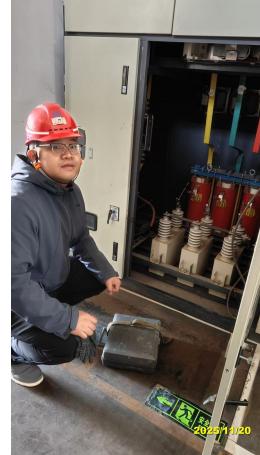
111	GX-B1332/21-1-25091~25102	2025.12.31	本次共检电力电容器 12台，12台电力电容器 所检项目合格

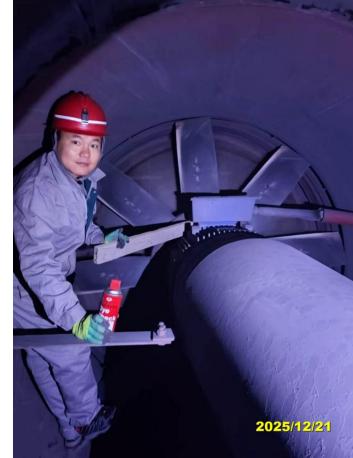
112	GX-B1428/21-1-25362	2025.12.29	无缺陷迹痕显示

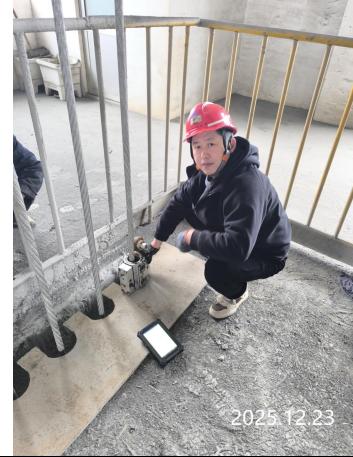
113	GX-B1598/24-1-25116	2025.12.31	实测钢丝绳有效截面 积损失百分比最大为 2.33%，小于5%为正常

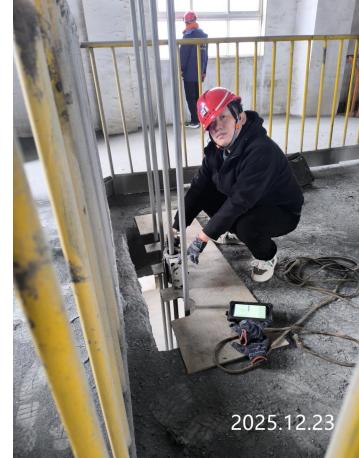
114	GX-B1598/24-1-25117	2025.12.31	实测钢丝绳有效截面积损失百分比最大为1.76%，小于5%为正常

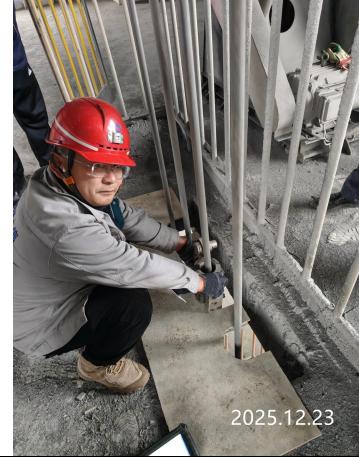
2025.12.23	
115	GX-B1598/24-1-25118	2025.12.31	实测钢丝绳有效截面积损失百分比最大为1.62%，小于5%为正常

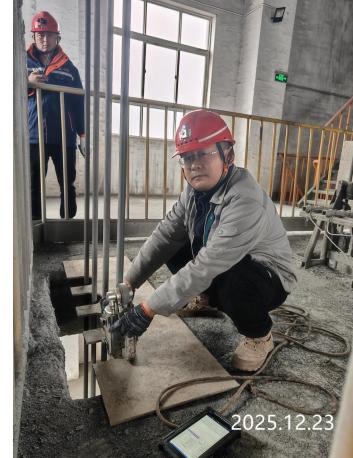
116	GX-B1598/24-1-25119	2025.12.31	实测钢丝绳有效截面积损失百分比最大为1.69%，小于5%为正常

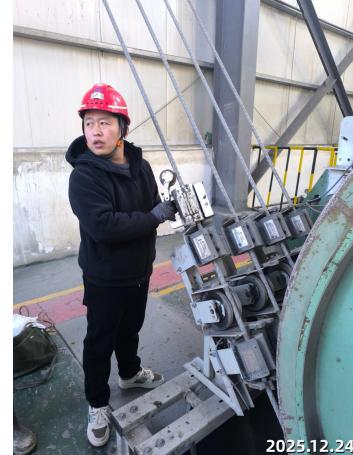
2025.12.23	
117	GX-B1598/24-1-25120	2025.12.31	实测钢丝绳有效截面积损失百分比最大为2.01%，小于5%为正常

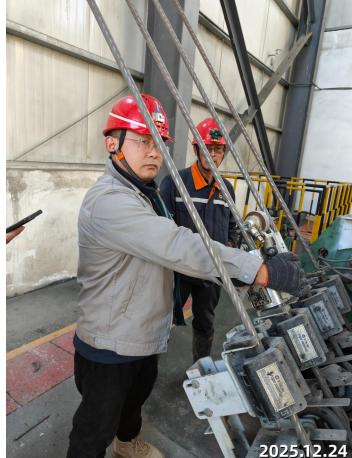
118	GX-B1598/24-1-25121	2025.12.31	实测钢丝绳有效截面 积损失百分比最大为 1.92%，小于5%为正常

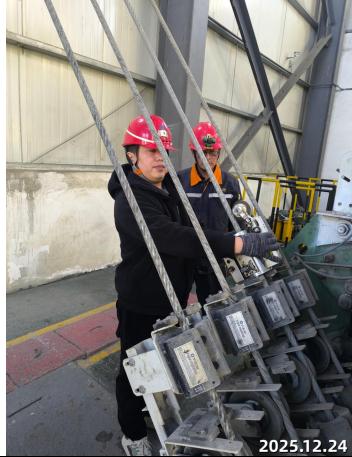
2025.12.24	
119	GX-B1598/24-1-25122	2025.12.31	实测钢丝绳有效截面 积损失百分比最大为 2.06%，小于5%为正常

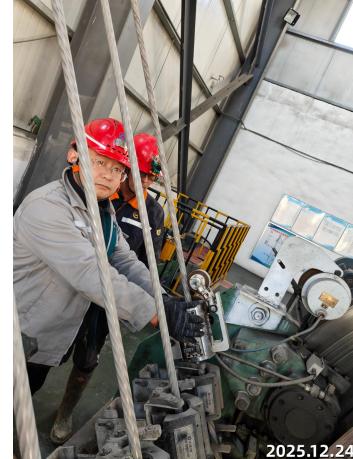
120	GX-B1598/24-1-25123	2025.12.31	实测钢丝绳有效截面 积损失百分比最大为 2.09%，小于5%为正常
