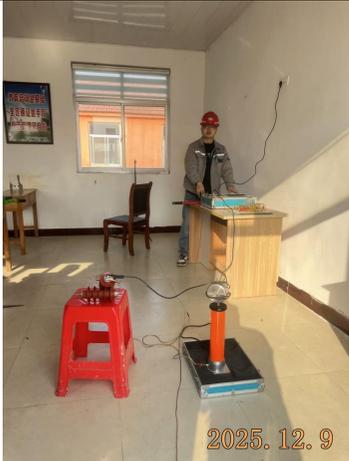
序号	报告编号	发布日期	结论	影像资料
118	GX-B1329/21-4-25206~25212	2025. 12. 25	本次共检氧化锌避雷器7组，7组氧化锌避雷器所检项目合格。

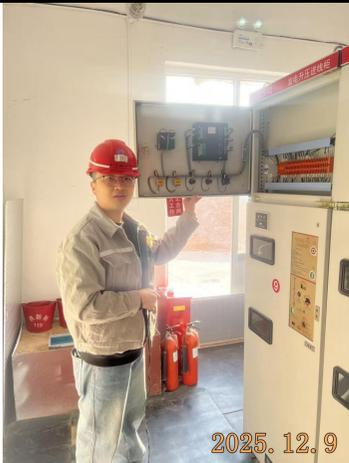
119	GX-B1451/20-4-25497~25502	2025. 12. 25	本次共检高压开关柜6面，6面高压开关柜所检项目合格。

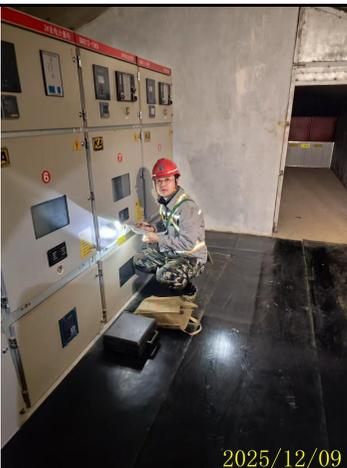
120	GX-B1451/20-4-25492~25496	2025. 12. 25	本次共检高压开关柜5台，5台高压开关柜所检项目合格。

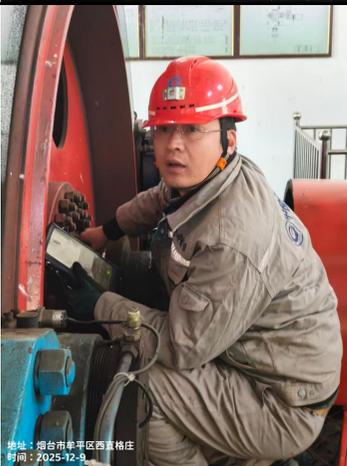
121	GX-B1310/21-4-25261	2025. 12. 24	符合标准要求

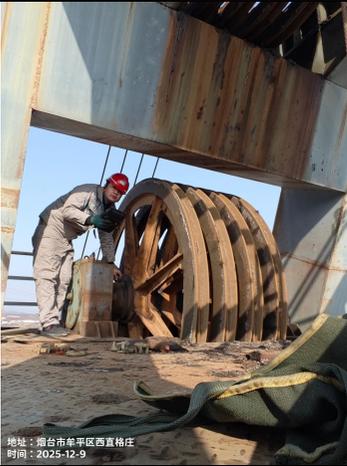
122	GX-B1310/21-4-25262	2025. 12. 24	符合标准要求

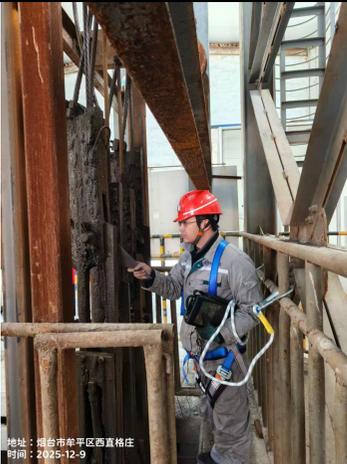
<p>地址：烟台南羊平区西直格庄 时间：2025-12-9</p>
123	GX-B1310/21-4-25263	2025. 12. 24	符合标准要求

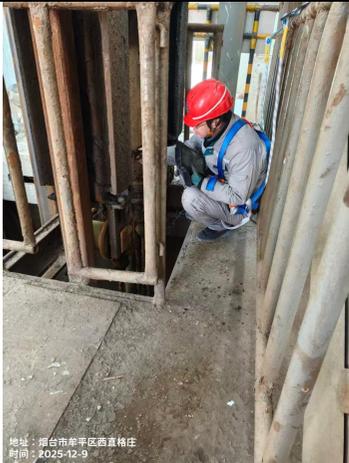
124	GX-B1310/21-4-25264	2025. 12. 24	符合标准要求

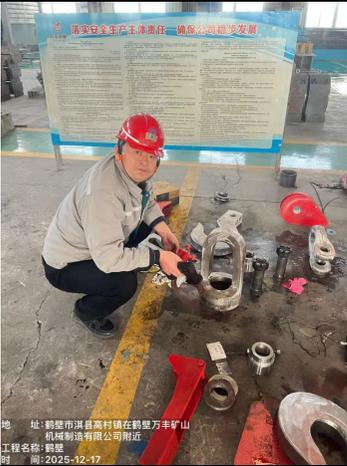
126	GX-B1427/21-4-25272	2025. 12. 22	符合标准要求

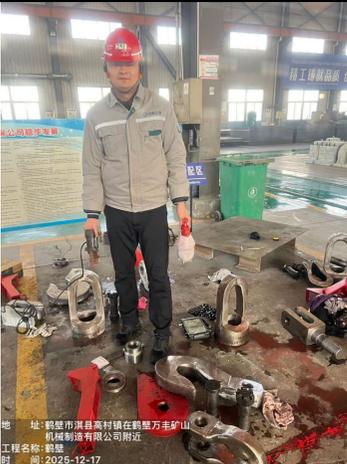
<p>地址: 鹤壁市淇县高村镇在鹤壁万丰矿山 机械制造有限公司附近 工程名称: 鹤壁 时间: 2025-12-17</p>
127	GX-B1427/21-4-25273	2025. 12. 22	符合标准要求

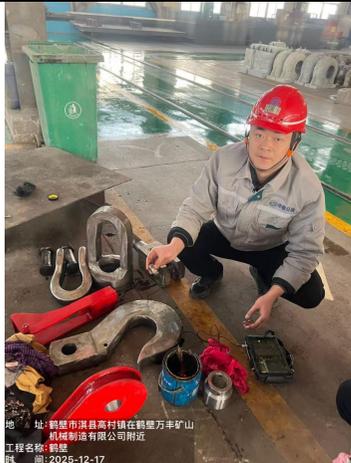
128	GX-B1310/21-4-25274	2025. 12. 29	符合标准要求

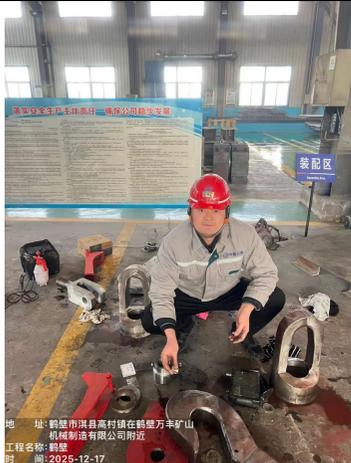
<p>地址: 鹤壁市淇县高村镇在鹤壁万丰矿山 机械制造有限公司附近 工程名称: 鹤壁 时间: 2025-12-17</p>
129	GX-B1310/21-4-25275	2025. 12. 29	符合标准要求

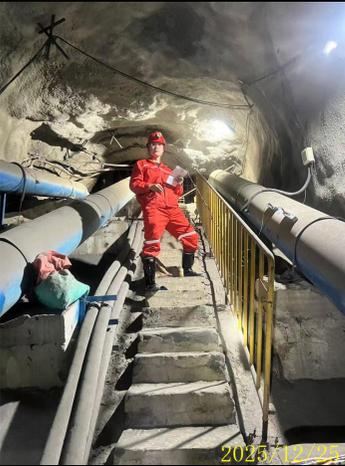
130	GX-B1309/21-4-25011	2025. 12. 29	所检项目合格。

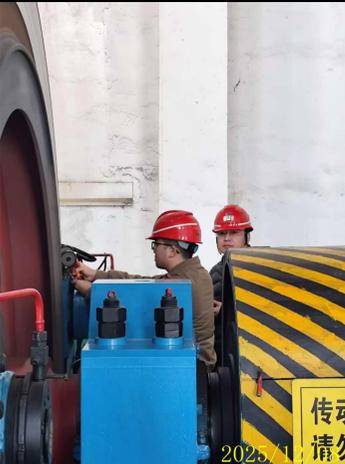
131	GX-B1304/21-4-25004	2025. 12. 29	综合判定：合格。

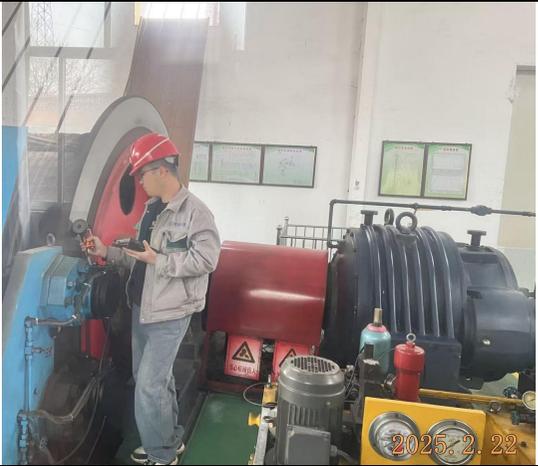
132	GX-B1304/21-4-25003	2025. 12. 29	综合判定：合格。

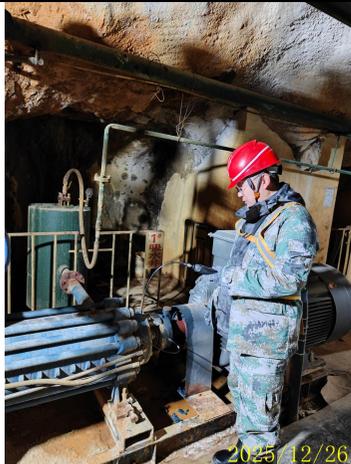
133	GX-B1500/21-4-25038	2025. 12. 31	综合判定：合格。

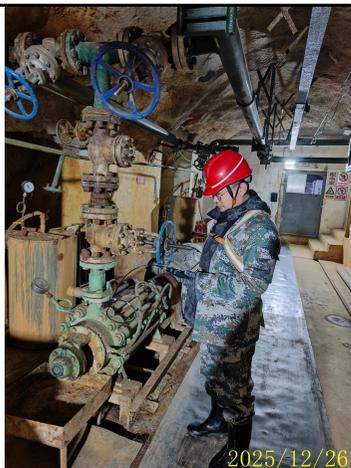
134	GX-B1500/21-4-25039	2025. 12. 31	综合判定：合格。

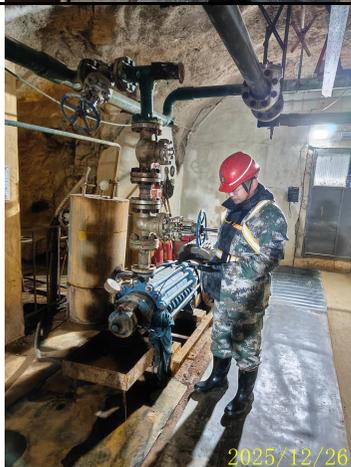
135	GX-B1500/21-4-25040	2025. 12. 31	综合判定：合格。

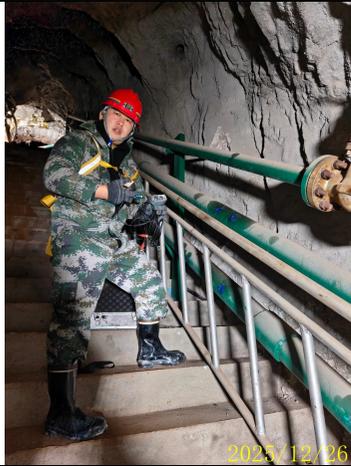
136	GX-B1309/21-4-25012	2025. 12. 31	所检项目合格。

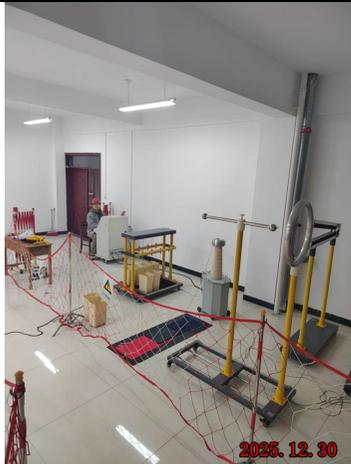
137	GX-B1328/25-4-25238	2025. 12. 31	本次共检绝缘胶垫 1个，1个绝缘胶垫合格。

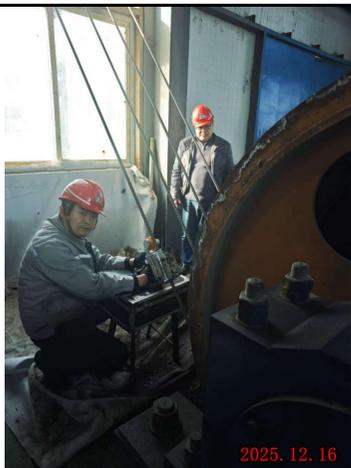
138	GX-B1598/24-4-25044	2025. 12. 31	实测钢丝绳有效截面积损失百分比最大为1.66%，小于5%为正常。 。

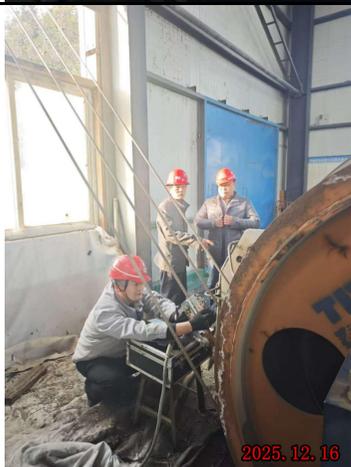
139	GX-B1598/24-4-25045	2025. 12. 31	实测钢丝绳有效截面积损失百分比最大为1.58%，小于5%为正常。 。

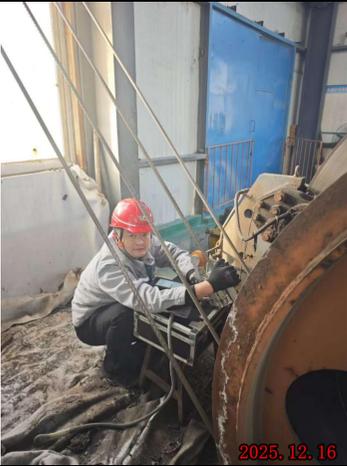
140	GX-B1598/24-4-25046	2025. 12. 31	实测钢丝绳有效截面积损失百分比最大为1.50%，小于5%为正常。 。

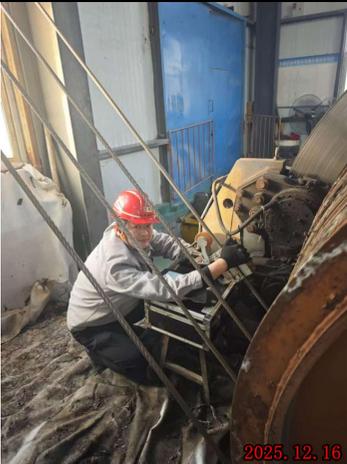
141	GX-B1598/24-4-25047	2025. 12. 31	实测钢丝绳有效截面积损失百分比最大为1.54%，小于5%为正常。 。
