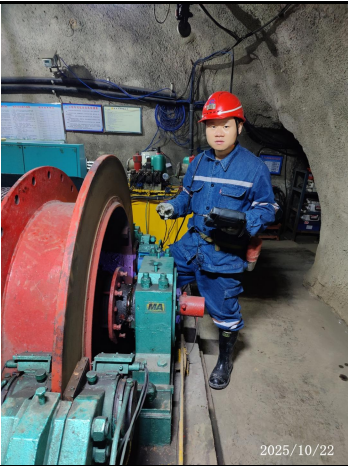
<p>2025/10/22</p>
172	GX-B1310/21-2-25470	2025. 11. 26	符合标准要求。

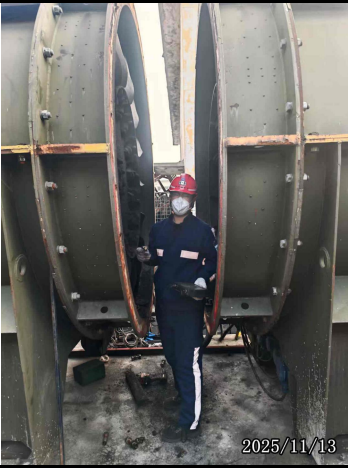
173	GX-B1428/21-2-25470	2025. 11. 26	无缺陷迹痕显示。	 
174	GX-B1321/20-2-25445~25452	2025. 11. 25	本次共检验电力电缆8条, 8条所检项目合格。 。

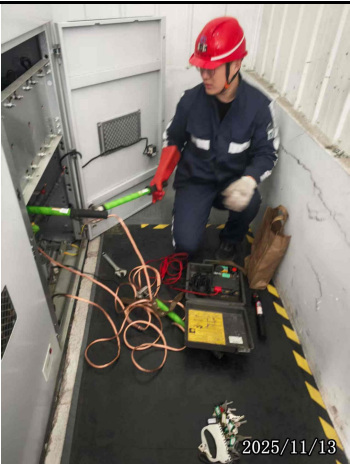
180	GX-B1310/21-2-25474	2025. 11. 26	符合标准要求。

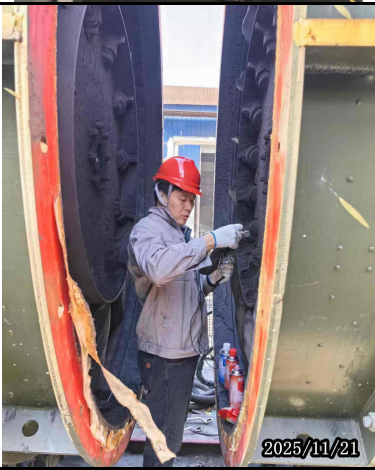
181	GX-B1428/21-2-25474	2025. 11. 26	无缺陷迹痕显示。	 
182	GX-B1310/21-2-25430	2025/11/28	符合标准要求。
