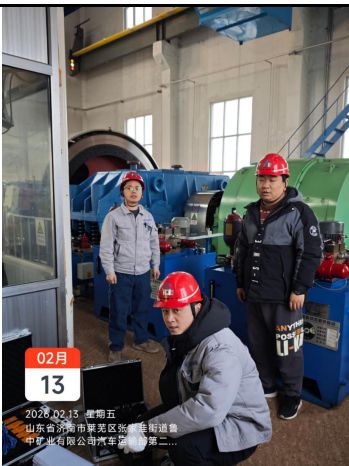
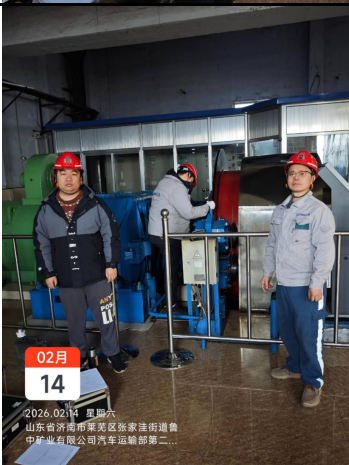
142	GX-B1304/26-2-26003	2026. 2. 21	综合判定：合格。	 
143	GX-B1304/26-2-26004	2026. 2. 21	综合判定：合格。

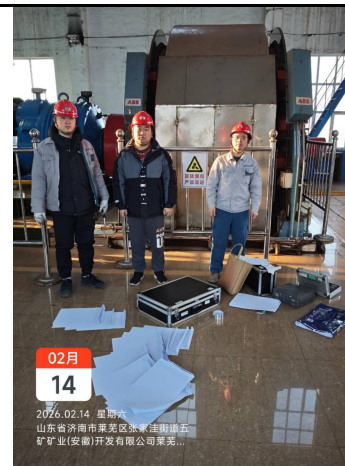
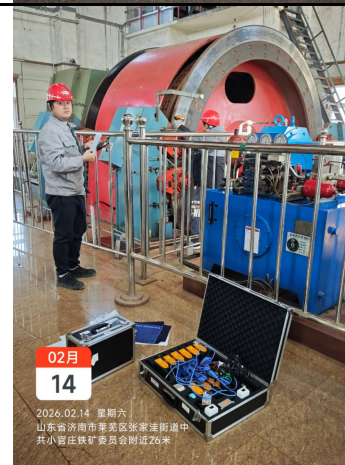
144	GX-B1304/26-2-26005	2026. 2. 21	综合判定：合格。	 
145	GX-B1304/26-2-26006	2026. 2. 21	综合判定：合格。

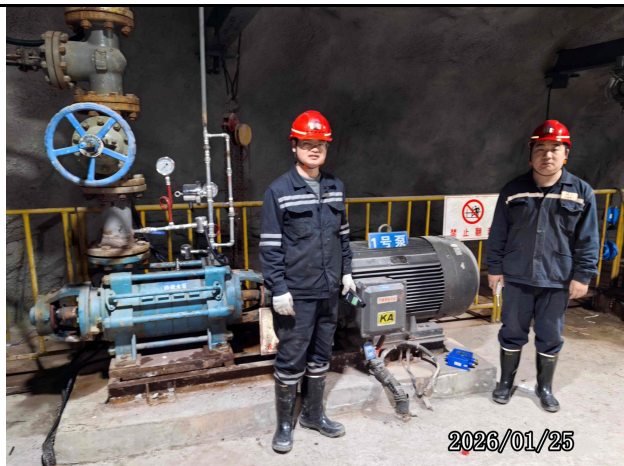
166	GX-B1500/21-2-26014	2026. 2. 26	综合判定：合格。

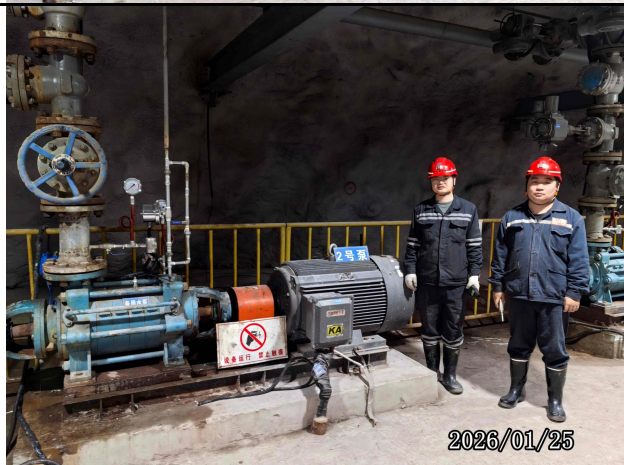
167	GX-B1500/21-2-26015	2026. 2. 26	综合判定：合格。
