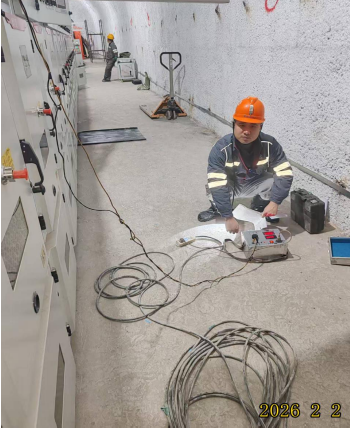
32	GX-B1451/25-6-26020~26032	2026/2/25	本次共检高压开关柜13台, 13台高压开关柜所检项目合格。

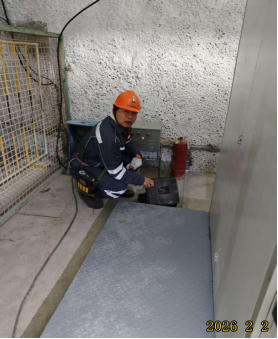
33	GX-B1350/21-6-26001	2026/2/25	本次共检接地装置1处, 1处接地装置所检项目合格。

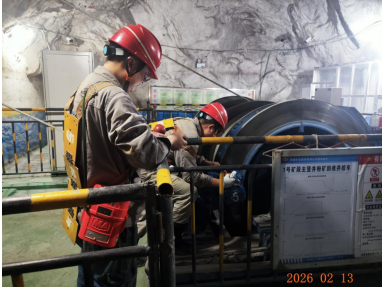
40	GX-B1305/21-6-26004	2026. 2. 27	综合判定：合格。

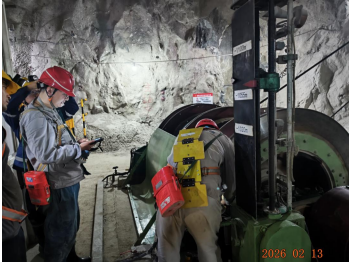
41	GX-B1305/21-6-26005	2026. 2. 27	综合判定：合格。

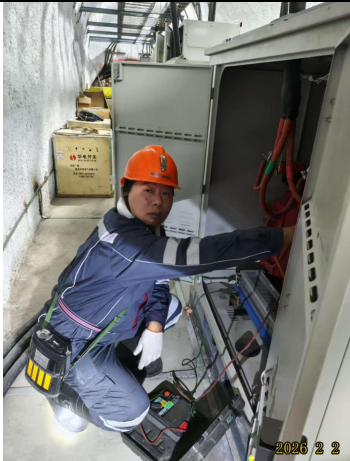
44	GX-B1313/21-6-26011~26012	2026/2/25	本次共检电力变压器2台，2台电力变压器所检项目合格。
