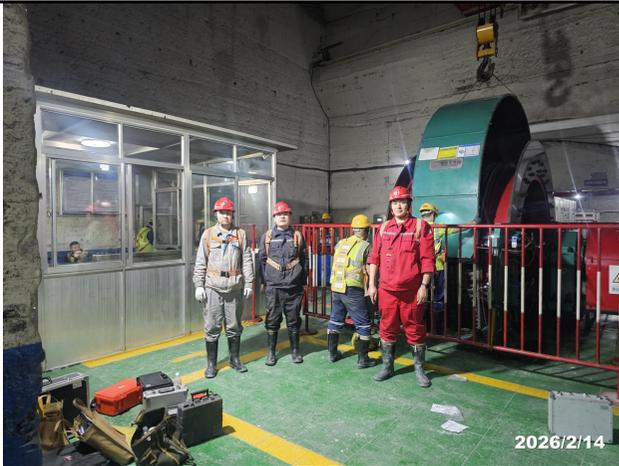
序号	报告编号	发布日期	结论	影像资料
1	GX-B1304/26-2-26009	2026/3/3	综合判定：合格。

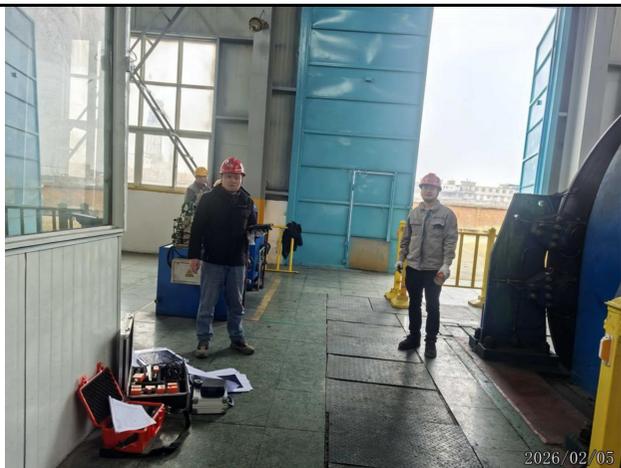
3	GX-B1304/26-2-26007	2026/3/2	综合判定：合格。

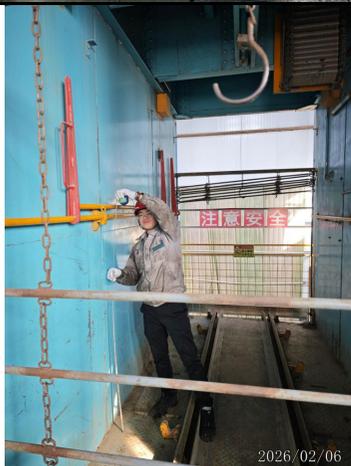
4	GX-B1380/26-2-26005	2026/3/2	所检项目合格。

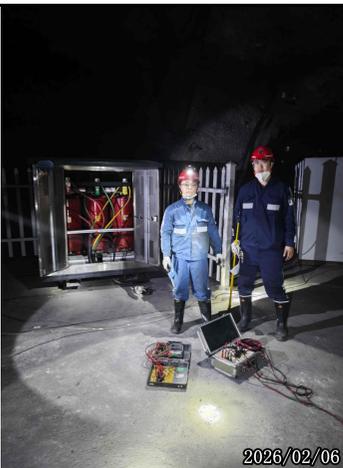
5	GX-B1313/26-2-26027~26032	2026/3/2	本次共检电力变压器6台，6台所检项目合格。 。

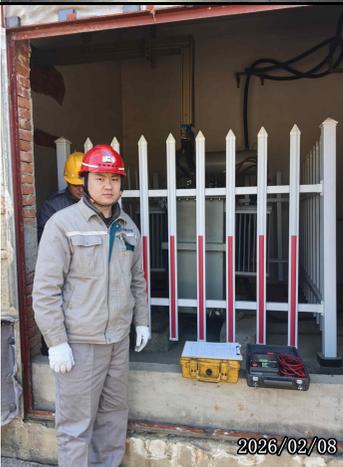
<p>2026/02/06</p>	
6	GX-B1313/26-2-26036~26043	2026/3/2	本次共检电力变压器8台，8台所检项目合格。 。

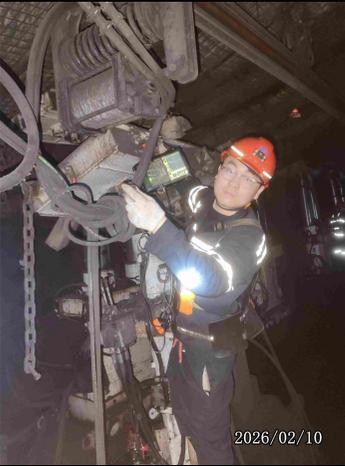
9	GX-B1310/21-2-26053	2026/3/2	符合标准要求。

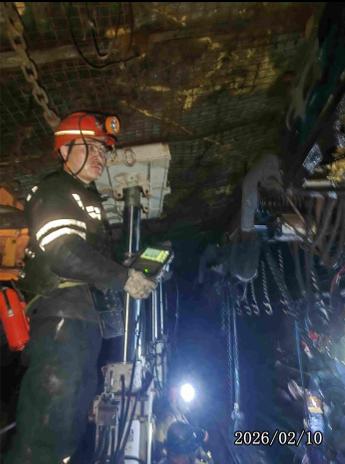
10	GX-B1310/21-2-26054	2026/3/2	符合标准要求。

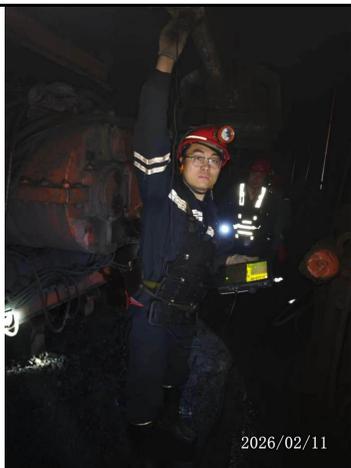
13	GX-B1310/21-2-26057	2026/3/3	符合标准要求。

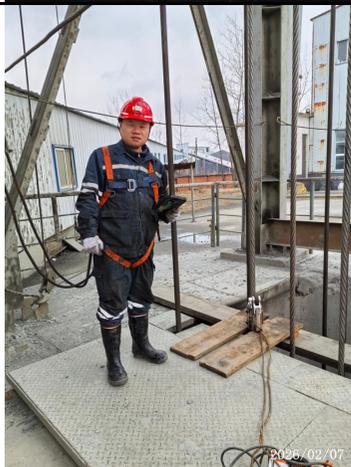
14	GX-B1598/24-2-26067	2026/3/3	实测钢丝绳有效截面积损失百分比最大为0.98%，小于5%为正常。

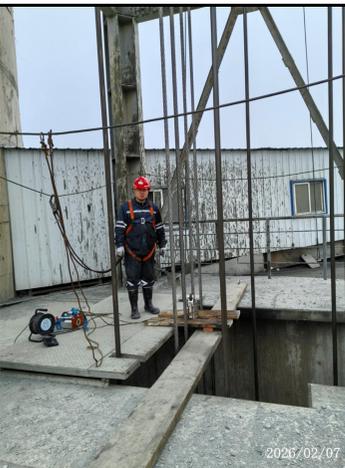
15	GX-B1598/24-2-26068	2026/3/3	实测钢丝绳有效截面积损失百分比最大为0.82%，小于5%为正常。

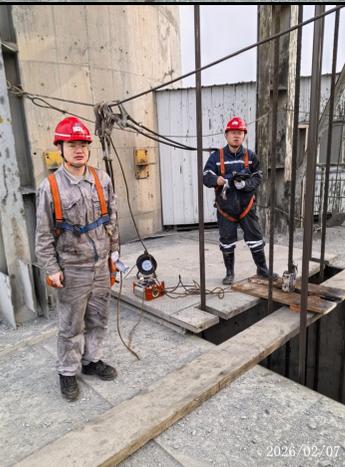
16	GX-B1598/24-2-26069	2026/3/3	实测钢丝绳有效截面积损失百分比最大为1.19%，小于5%为正常。

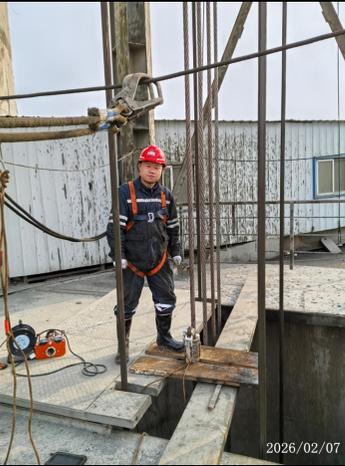
17	GX-B1598/24-2-26070	2026/3/3	实测钢丝绳有效截面积损失百分比最大为1.38%，小于5%为正常。 。

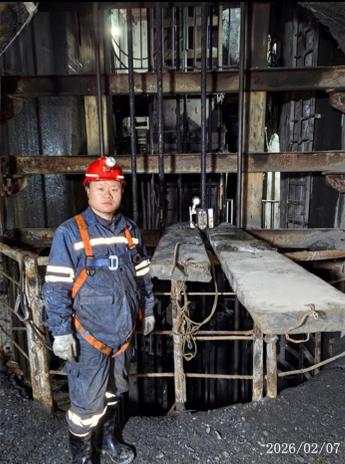
18	GX-B1598/24-2-26071	2026/3/3	实测钢丝绳有效截面积损失百分比最大为0.89%，小于5%为正常。 。

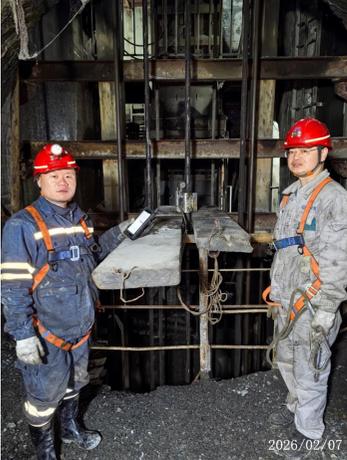
19	GX-B1598/24-2-26072	2026/3/3	实测钢丝绳有效截面积损失百分比最大为0.48%，小于5%为正常。 。

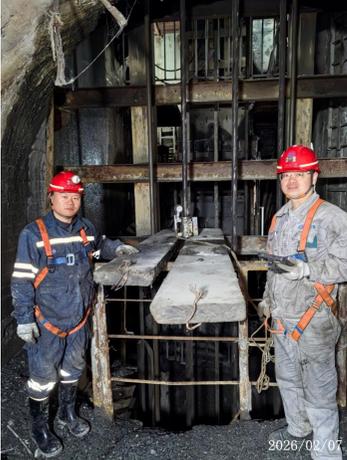
A photograph showing two workers in a mine. One worker is wearing a blue uniform and a red helmet, while the other is wearing a grey uniform and a red helmet. They are standing next to a large piece of machinery or a structure, possibly related to the steel cable inspection mentioned in the text. The date '2026/02/07' is visible in the bottom right corner of the photo.
20	GX-B1598/24-2-26073	2026/3/3	实测钢丝绳有效截面积损失百分比最大为0.44%，小于5%为正常。 。

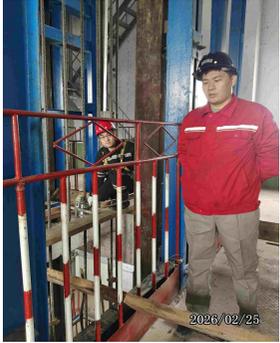
24	GX-B1598/24-2-26077	2026. 3. 3	实测钢丝绳有效截面积损失百分比最大为0.59%，小于5%为正常。

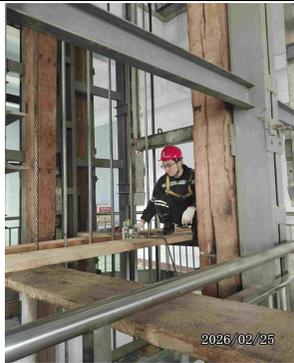
<p>2026/02/25</p>
28	GX-B1598/24-2-26081	2026. 3. 3	实测钢丝绳有效截面积损失百分比最大为0.50%，小于5%为正常。

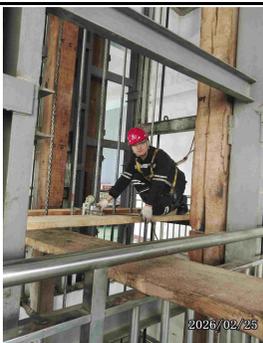
30	GX-B1598/24-2-26083	2026. 3. 3	实测钢丝绳有效截面积损失百分比最大为0.39%，小于5%为正常。

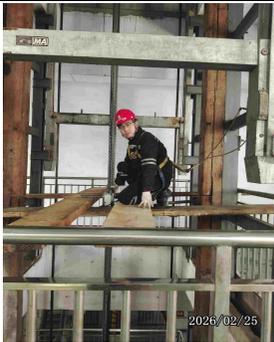
32	GX-B1598/24-2-26085	2026. 3. 3	实测钢丝绳有效截面积损失百分比最大为0.43%，小于5%为正常。

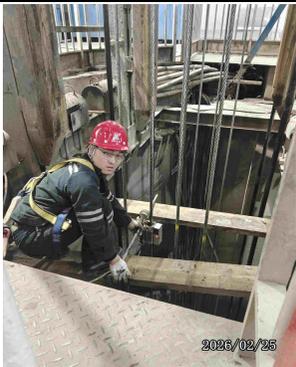
34	GX-B1598/24-2-26087	2026. 3. 3	实测钢丝绳有效截面积损失百分比最大为1.05%，小于5%为正常。

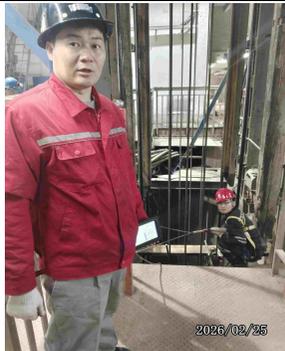
36	GX-B1598/24-2-26089	2026. 3. 3	实测钢丝绳有效截面积损失百分比最大为0.99%，小于5%为正常。

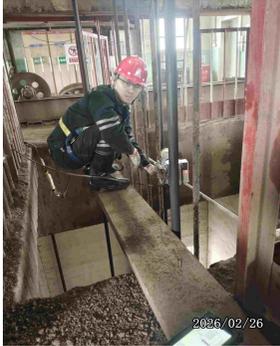
38	GX-B1598/24-2-26091	2026. 3. 3	实测钢丝绳有效截面积损失百分比最大为0.83%，小于5%为正常。

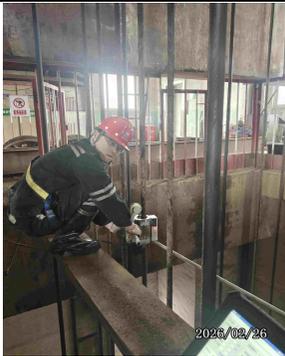
39	GX-B1598/24-2-26092	2026. 3. 3	实测钢丝绳有效截面积损失百分比最大为0.99%，小于5%为正常。

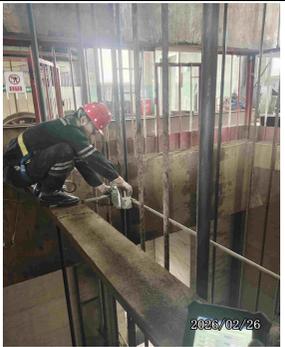
40	GX-B1598/24-2-26093	2026. 3. 3	实测钢丝绳有效截面积损失百分比最大为1.05%，小于5%为正常。

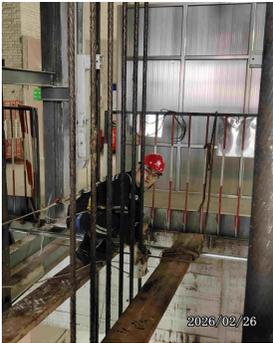
43	GX-B1598/24-2-26096	2026. 3. 3	实测钢丝绳有效截面积损失百分比最大为0.51%，小于5%为正常。

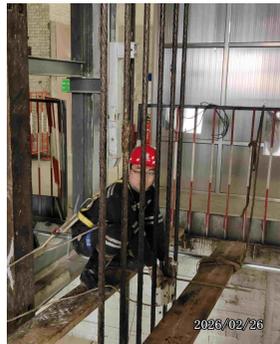
44	GX-B1598/24-2-26097	2026. 3. 3	实测钢丝绳有效截面积损失百分比最大为0.66%，小于5%为正常。

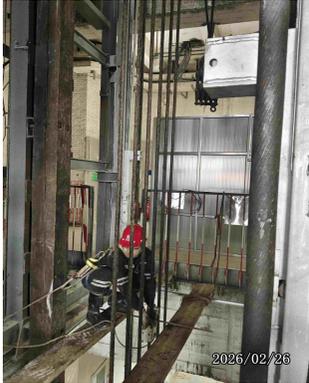
45	GX-B1598/24-2-26098	2026. 3. 3	实测钢丝绳有效截面积损失百分比最大为0.54%，小于5%为正常。

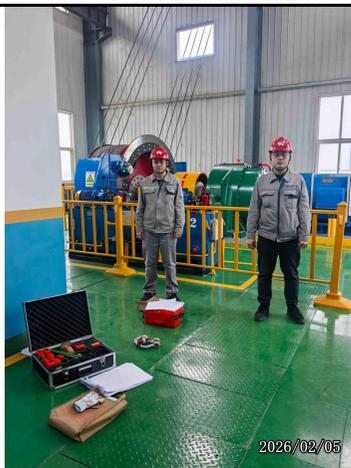
49	GX-B1304/26-2-26008	2026. 3. 2	综合判定：合格

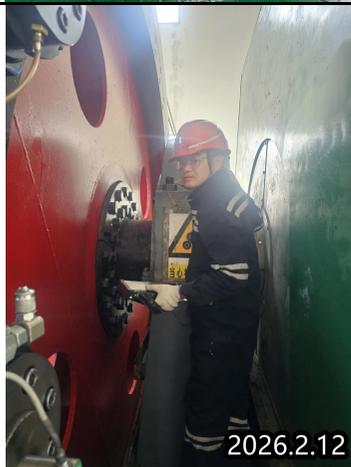
<p>2026/02/05</p>
50	GX-B1310/21-2-26073	2026. 3. 3	符合标准要求。

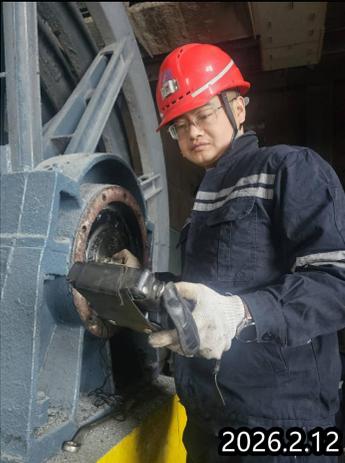
51	GX-B1310/21-2-26074	2026. 3. 3	符合标准要求。

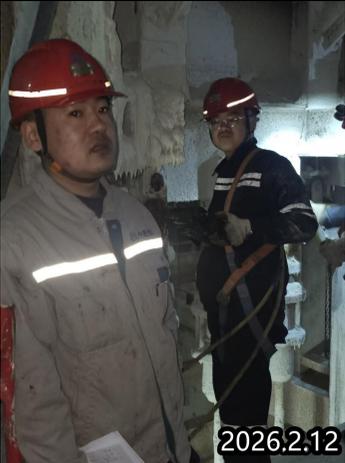
52	GX-B1310/21-2-26075	2026. 3. 3	符合标准要求。

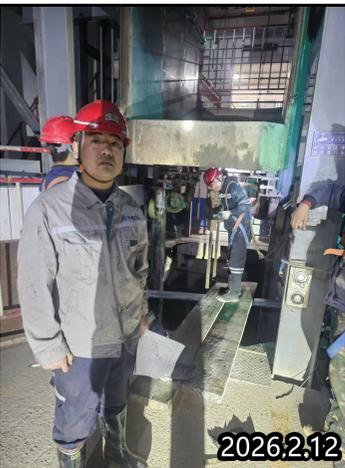
55	GX-B1310/21-2-26078	2026. 3. 3	符合标准要求。

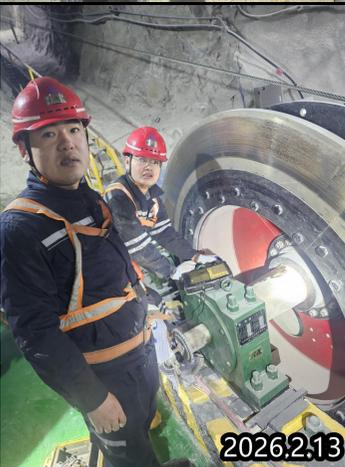
56	GX-B1310/21-2-26079	2026. 3. 3	符合标准要求。

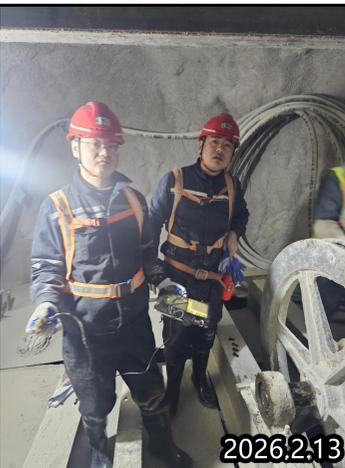
57	GX-B1310/21-2-26080	2026. 3. 3	符合标准要求。

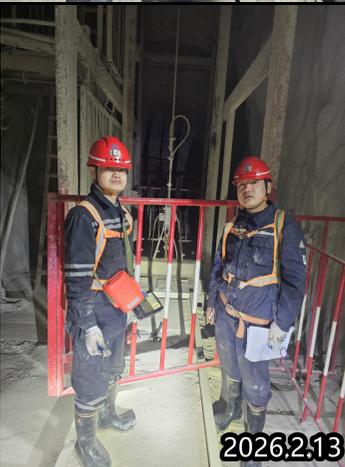
<p>2026.2.13</p>
58	GX-B1310/21-2-26081	2026. 3. 3	符合标准要求。

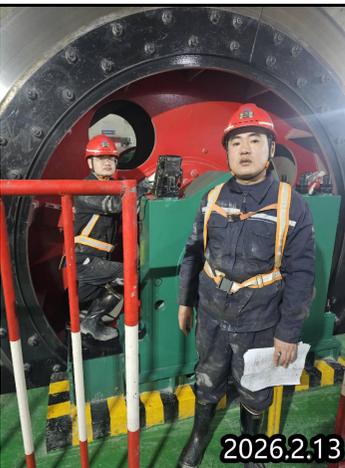
59	GX-B1310/21-2-26082	2026. 3. 3	符合标准要求。

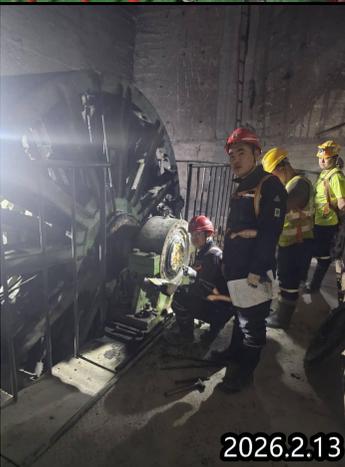
60	GX-B1310/21-2-26083	2026. 3. 3	符合标准要求。

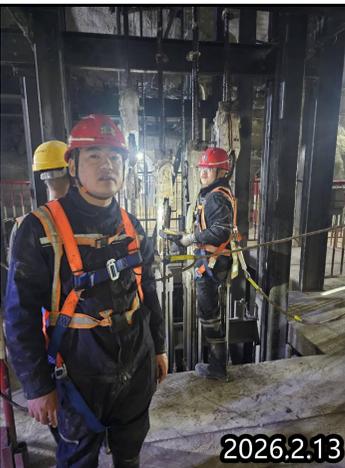
61	GX-B1310/21-2-26084	2026. 3. 3	符合标准要求。

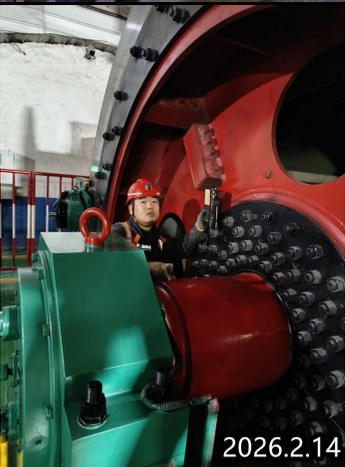
62	GX-B1310/21-2-26085	2026. 3. 3	符合标准要求。

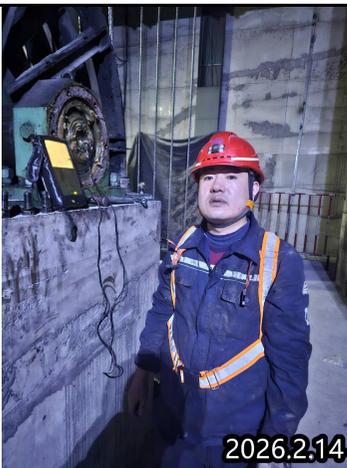
63	GX-B1310/21-2-26086	2026. 3. 3	符合标准要求。

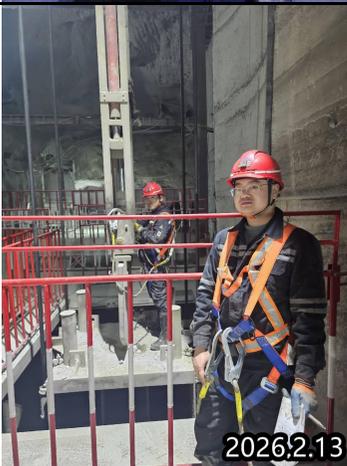
64	GX-B1310/21-2-26087	2026. 3. 3	符合标准要求。

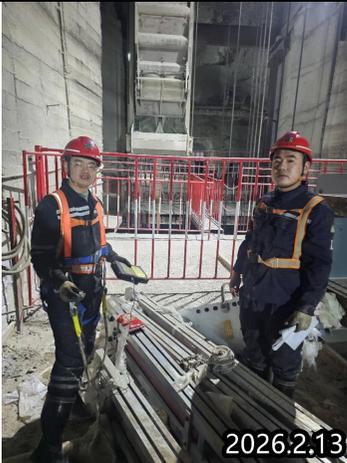
65	GX-B1310/21-2-26088	2026. 3. 3	符合标准要求。

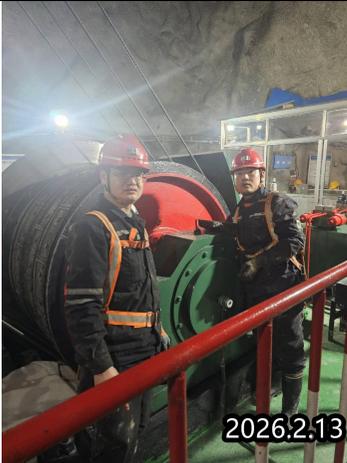
<p>2026.2.13</p>
66	GX-B1310/21-2-26089	2026. 3. 3	符合标准要求。

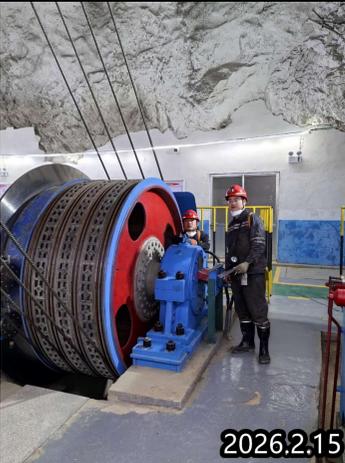
69	GX-B1310/21-2-26092	2026. 3. 4	符合标准要求。

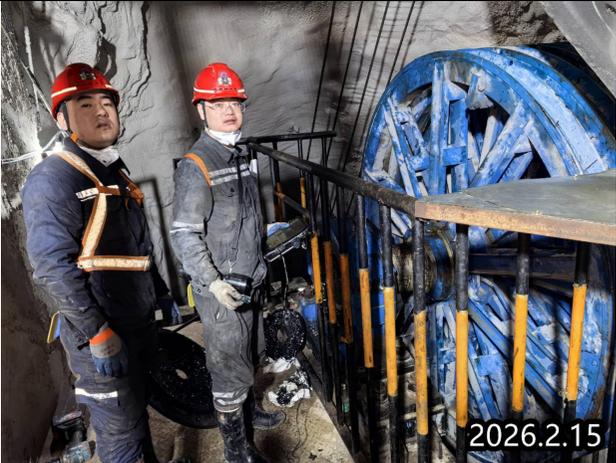
70	GX-B1310/21-2-26093	2026. 3. 4	符合标准要求。

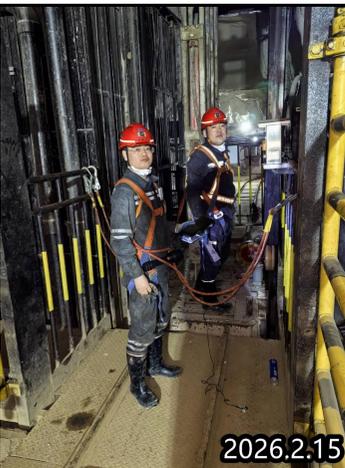
71	GX-B1310/21-2-26094	2026. 3. 4	符合标准要求。

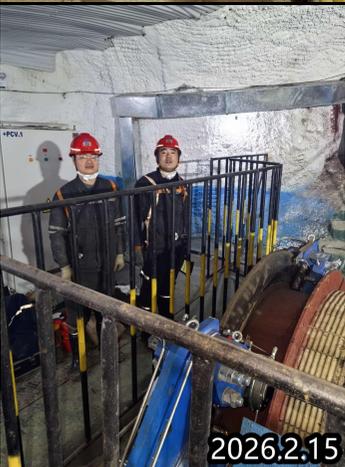
72	GX-B1310/21-2-26095	2026. 3. 4	符合标准要求。

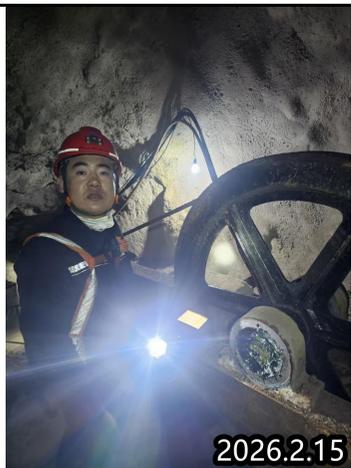
73	GX-B1310/21-2-26096	2026. 3. 4	符合标准要求。

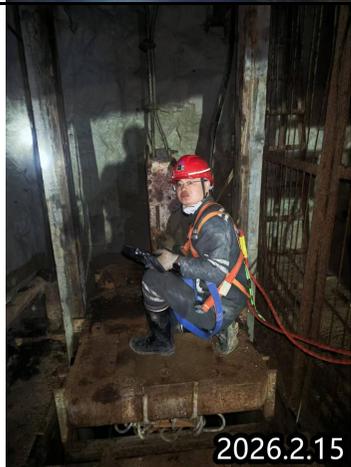
74	GX-B1310/21-2-26097	2026. 3. 4	符合标准要求。

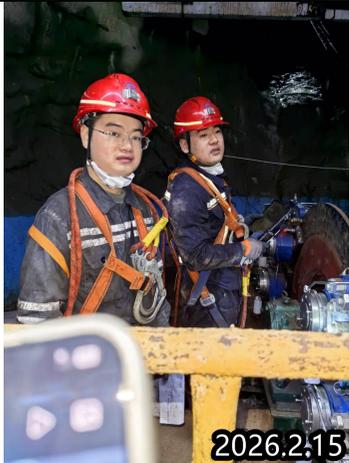
75	GX-B1310/21-2-26098	2026. 3. 4	符合标准要求。

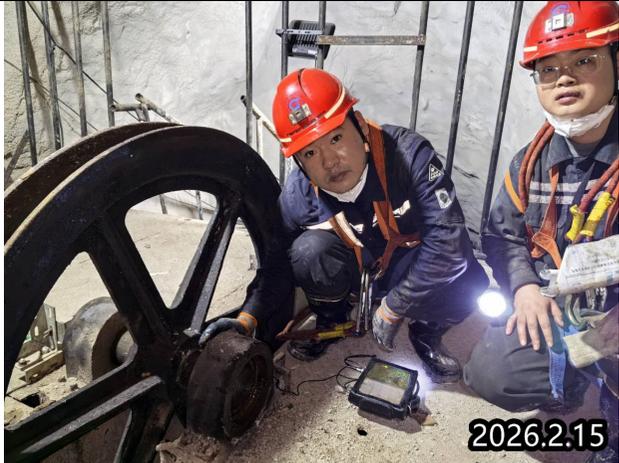
76	GX-B1310/21-2-26099	2026. 3. 4	符合标准要求。

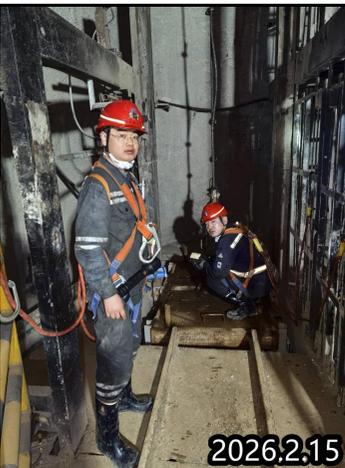
77	GX-B1310/21-2-26100	2026. 3. 4	符合标准要求。

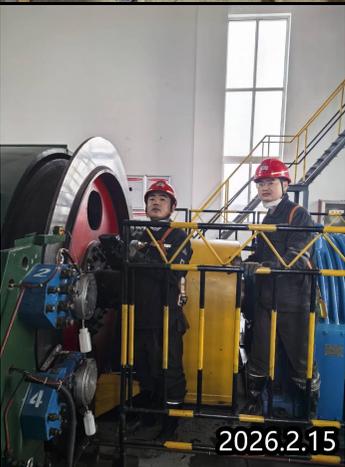
78	GX-B1310/21-2-26103	2026. 3. 4	符合标准要求。

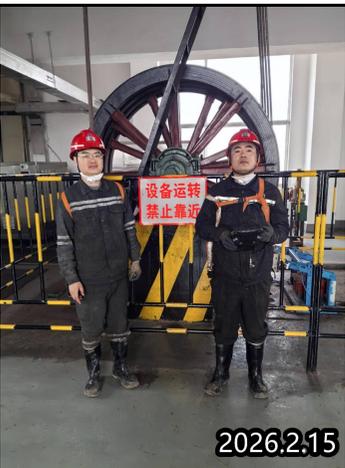
79	GX-B1310/21-2-26104	2026. 3. 4	符合标准要求。

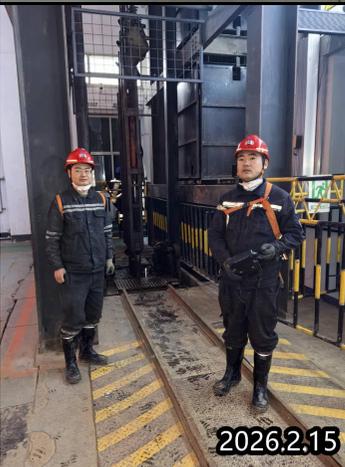
<p>设备运转 禁止靠近</p> <p>2026.2.15</p>
80	GX-B1310/21-2-26105	2026. 3. 4	符合标准要求。

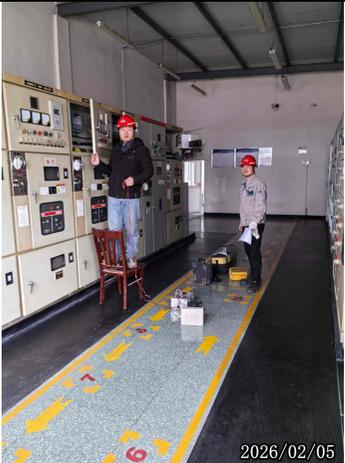
81	GX-B1451/26-2-26106~26111	2026. 3. 3	本次共检高压开关柜6台，6台高压开关柜所检项目合格。

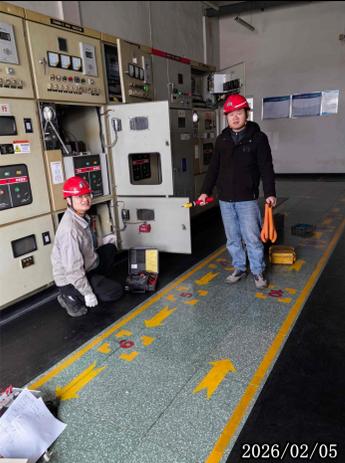
<p>2026/02/05</p>
82	GX-B1322/26-2-26036~26038	2026. 3. 3	本次共检验电力电缆3条，3条所检项目合格。

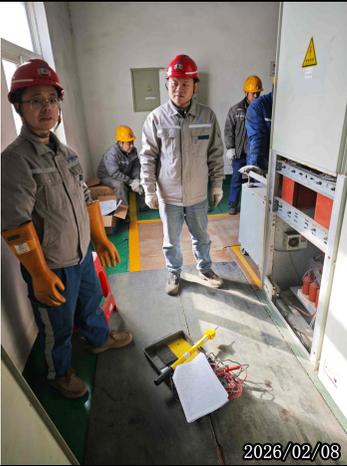
83	GX-B1322/26-2-26042~26048	2026. 3. 3	本次共检验电力电缆 7条，7条所检项目合 格。

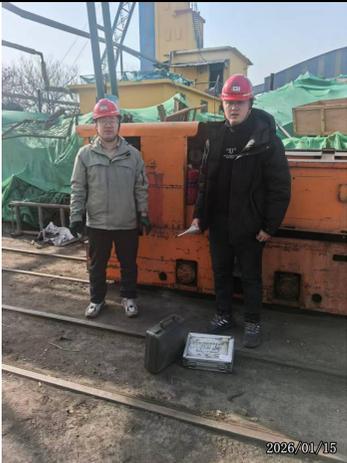
84	GX-B1517/20-2-26001	2026. 3. 2	综合判定：合格。

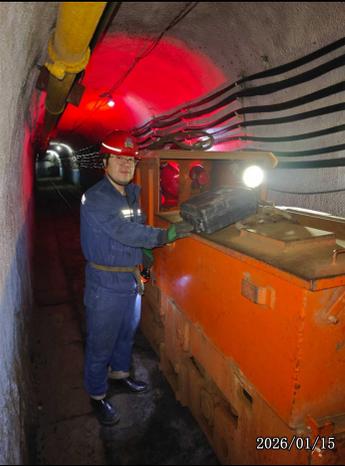
85	GX-B1517/20-2-26002	2026. 3. 2	综合判定：合格。

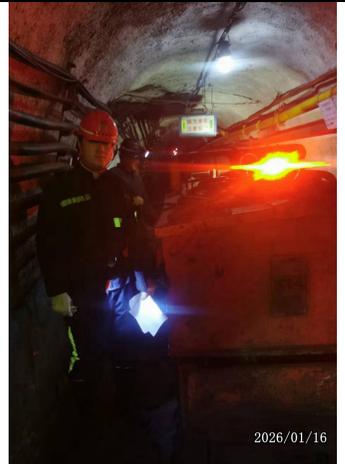
86	GX-B1517/20-2-26003	2026. 3. 2	综合判定：合格。

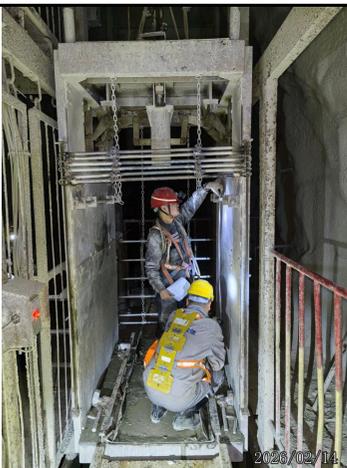
87	GX-B1380/26-2-26006	2026. 3. 5	所检项目合格。

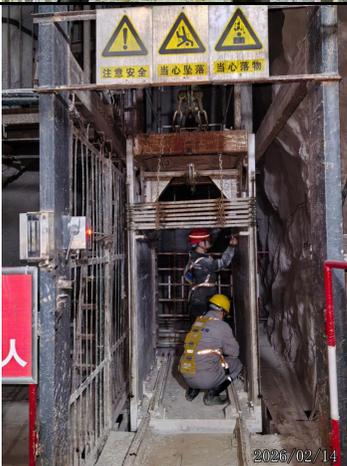
88	GX-B1380/26-2-26007	2026. 3. 5	所检项目合格。

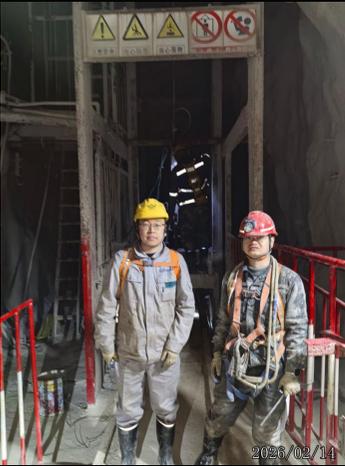
89	GX-B1382/26-2-26001	2026. 3. 5	综合判定：合格。

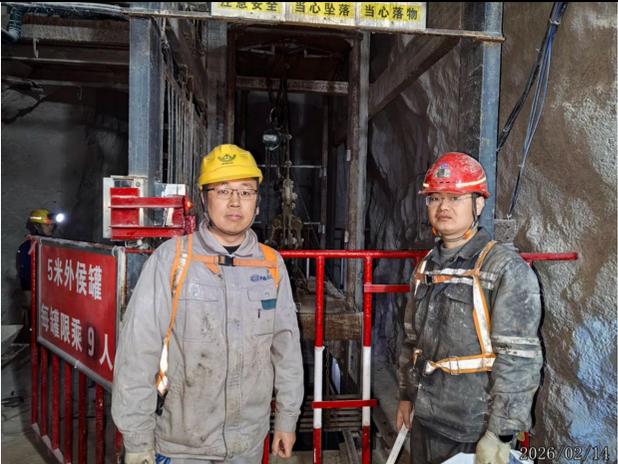
A photograph showing two workers in safety gear (hard hats, safety harnesses) standing in a tunnel. The worker on the left is wearing a yellow hard hat and a light-colored jacket, while the worker on the right is wearing a red hard hat and a dark jacket. They are standing in front of a metal structure with warning signs. The date '2026.02.14' is visible in the bottom right corner of the photo.
90	GX-B1382/26-2-26002	2026. 3. 5	综合判定：合格。

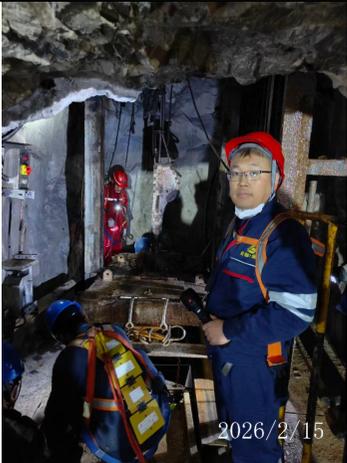
91	GX-B1382/26-2-26003	2026. 3. 5	综合判定：合格。

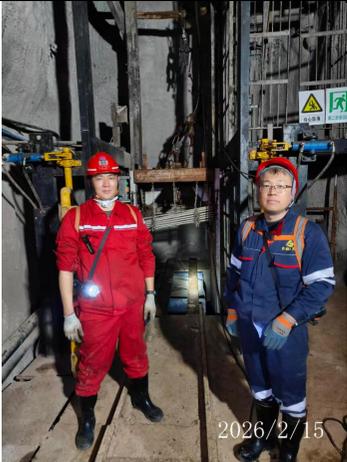
92	GX-B1382/26-2-26004	2026. 3. 5	综合判定：合格。

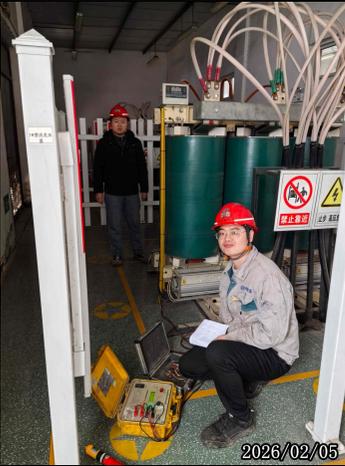
93	GX-B1313/26-2-26044~26046	2026. 3. 5	本次共检电力变压器3台，3台所检项目合格。

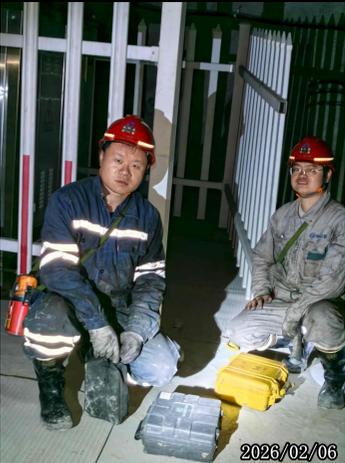
94	GX-B1313/26-2-26047~26051	2026. 3. 5	本次共检电力变压器5台，5台所检项目合格。
