序号	报告编号	发布日期	结论	影像资料
1	GX-B1382/26-6-26001	2026/3/2	综合判定合格

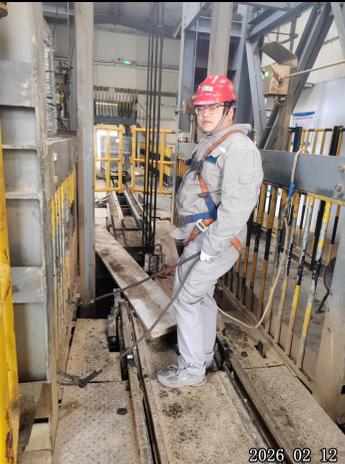
10	GX-B1598/24-6-26010	2026/3/2	实测钢丝绳有效截面积损失百分比最大为4.16%，小于5%为正常。

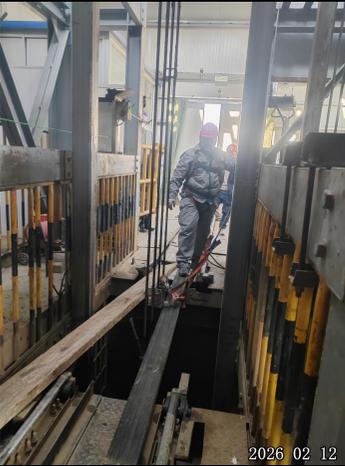
11	GX-B1598/24-6-26011	2026/3/2	实测钢丝绳有效截面积损失百分比最大为4.09%，小于5%为正常。

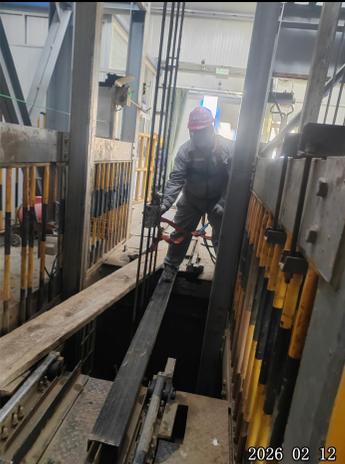
12	GX-B1598/24-6-26012	2026/3/2	实测钢丝绳有效截面积损失百分比最大为4.27%，小于5%为正常。

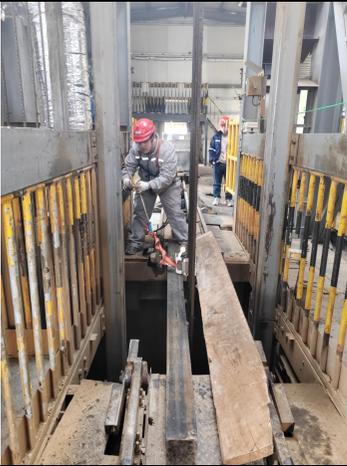
13	GX-B1598/24-6-26013	2026/3/2	实测钢丝绳有效截面积损失百分比最大为4.01%，小于5%为正常。

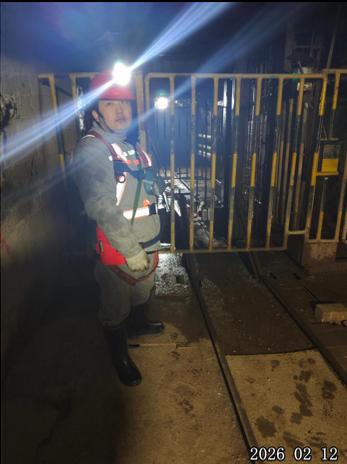
14	GX-B1598/24-6-26014	2026/3/2	实测钢丝绳有效截面积损失百分比最大为3.22%，小于5%为正常。

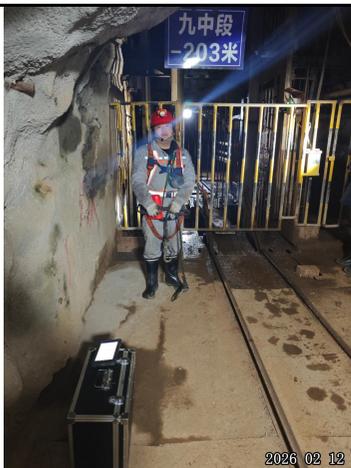
15	GX-B1598/24-6-26015	2026/3/2	实测钢丝绳有效截面积损失百分比最大为3.09%，小于5%为正常。

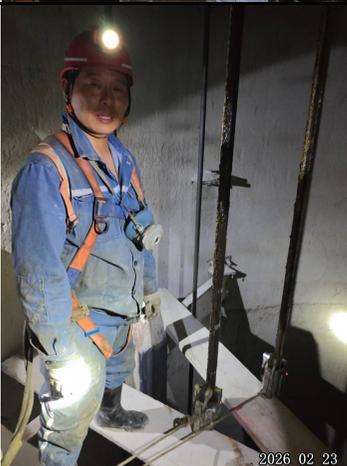
<p>2026 02 24</p>
62	GX-B1598/24-6-26051	2026. 3. 4	实测钢丝绳有效截面积损失百分比最大为4.98%，小于5%为正常。

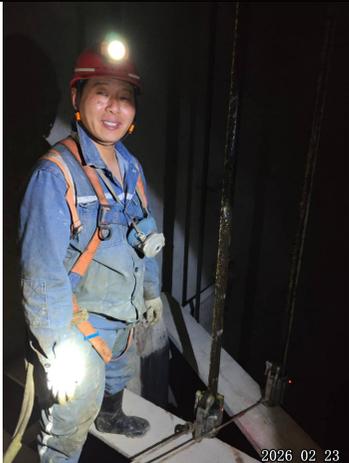
63	GX-B1598/24-6-26052	2026. 3. 4	实测钢丝绳有效截面积损失百分比最大为4.80%，小于5%为正常。

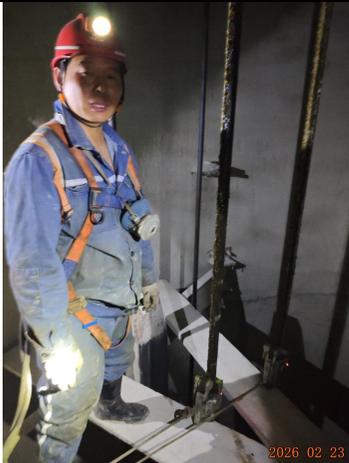
<p>2026 03 23</p>
74	GX-B1598/24-6-26057	2026/3/4	实测钢丝绳有效截面积损失百分比最大为8.64%，小于10%，被测钢丝绳可在加强养护的条件下继续使用。

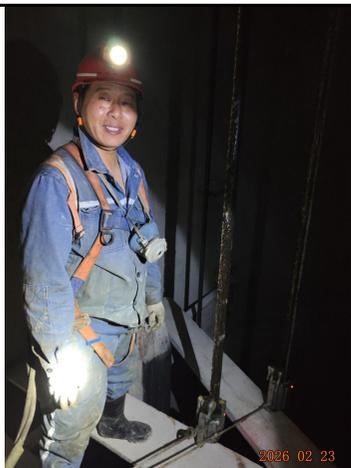
75	GX-B1598/24-6-26058	2026/3/4	实测钢丝绳有效截面积损失百分比最大为8.50%，小于10%，被测钢丝绳可在加强养护的条件下继续使用。
