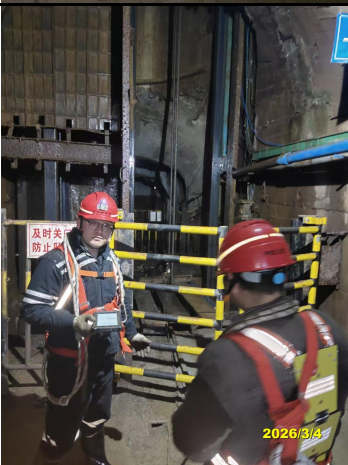
25	GX-B1598/24-5-26033	2026. 3. 6	实测钢丝绳有效截面积损失百分比最大为3.12%，小于5%为正常。	  A photograph showing two workers in red hard hats and safety harnesses standing in an industrial environment. They appear to be inspecting a piece of machinery or a steel cable. A yellow date stamp '2026/3/4' is visible in the bottom right corner of the image.
26	GX-B1598/24-5-26034	2026. 3. 6	实测钢丝绳有效截面积损失百分比最大为3.33%，小于5%为正常。

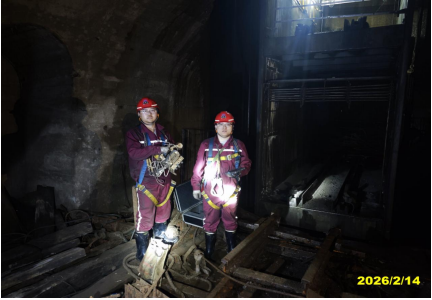
47	GX-B1598/24-5-26037	2026/3/9	实测钢丝绳有效截面积损失百分比最大为2.71%，小于5%为正常。

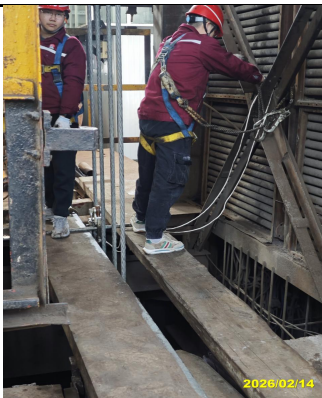
55	GX-B1598/24-5-26039	2026/3/9	实测钢丝绳有效截面积损失百分比最大为1.12%，小于5%为正常。

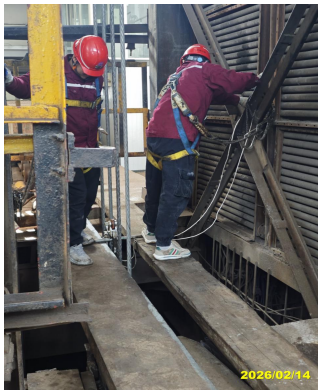
56	GX-B1598/24-5-26040	2026/3/9	实测钢丝绳有效截面积损失百分比最大为1.96%，小于5%为正常。

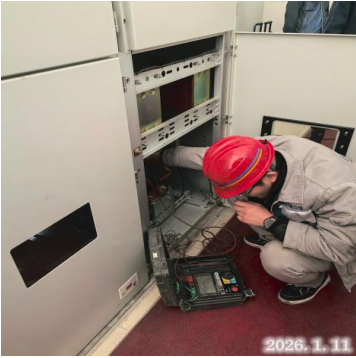
93	GX-B1321/20-5-26053~26062	2026/3/12	本次共检电力电缆10条，10条电力电缆所检项目合格。

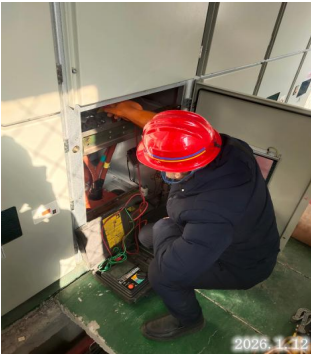
94	GX-B1321/20-5-26063~26066	2026/3/12	本次共检电力电缆4条，4条电力电缆所检项目合格。
