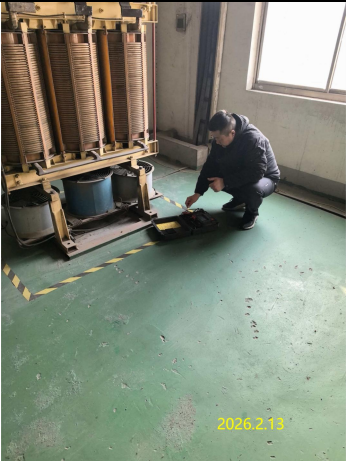
| 158 | GX-B1312/26-7-26093~26098 | 2026. 3. 24 | 本次共检电力变压器6台，6台电力变压器所检项目合格。 | |

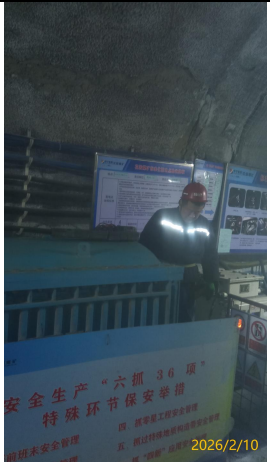
| 159 | GX-B1312/26-7-26084~26087 | 2026. 3. 24 | 本次共检电力变压器4台，4台电力变压器所检项目合格。 | |

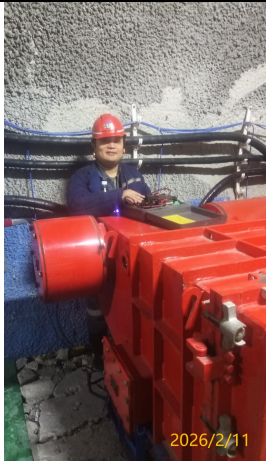
| 160 | GX-B1321/26-7-26059~26064 | 2026. 3. 24 | 本次共检电力电缆6条，6条电力电缆所检项目合格。 | |

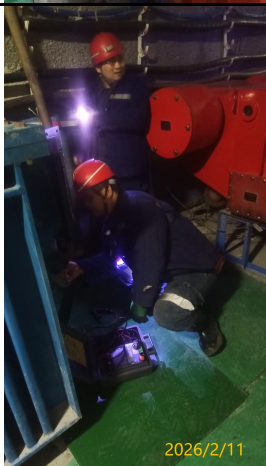
| 161 | GX-B1312/26-7-26088~26089 | 2026. 3. 24 | 本次共检电力变压器2台，2台电力变压器所检项目合格。 | |
