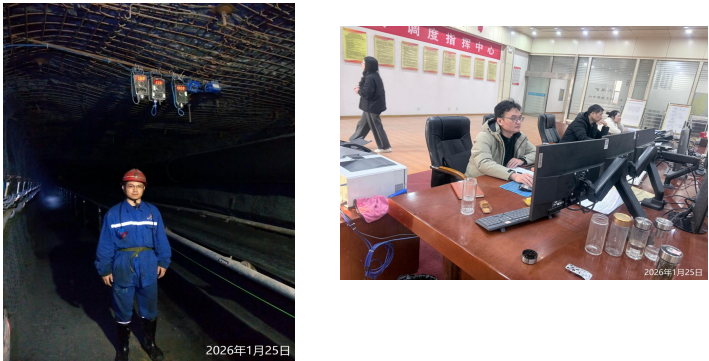
19	GX-B1370/21-9-26004	2026年4月13日	存在问题： 安全监控布置图中风门传感器型号错误。 除上述问题外，其余所检项目合格。
