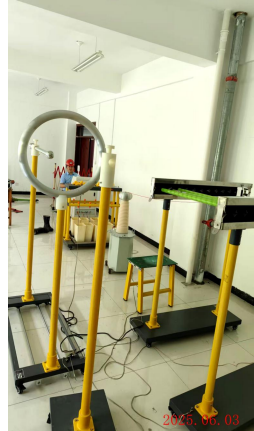
| 26 | GX-B1328/20-1-25061 | 2025. 6. 6 | 本次共检绝缘杆1套，1套绝缘杆合格 | |

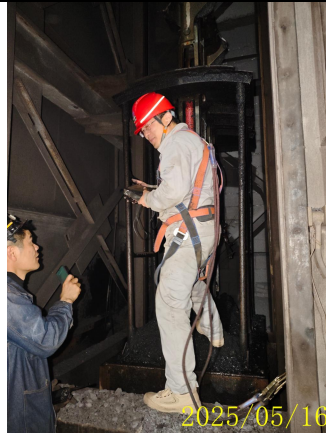
| 48 | GX-B1310/21-1-25129 | 2025. 6. 12 | 符合标准要求 | <p>2025/05/16</p> |
