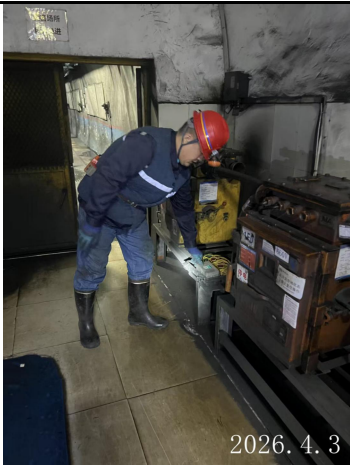
序号	报告编号	发布日期	结论	影像资料
1	GX-B1350/21-7-26025	2026. 6. 1	所检项目合格。

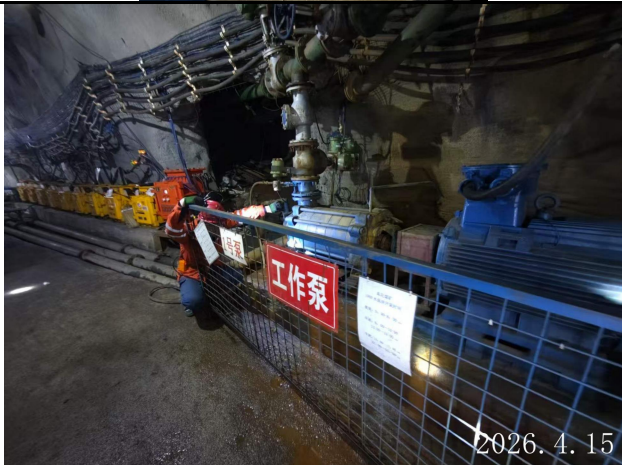
2	GX-B1308/26-7-26007	2026. 6. 2	综合判定：合格。

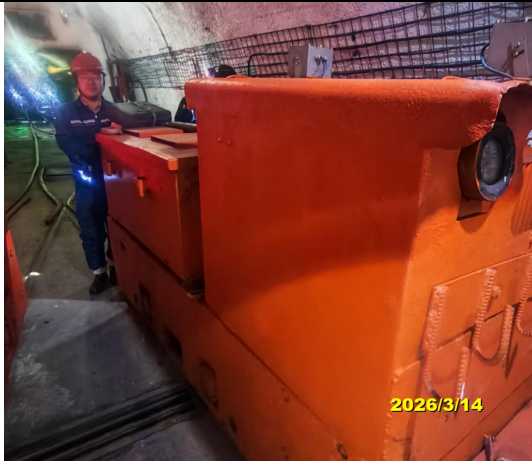
11	GX-B1517/26-7-26015	2026/6/1	综合判定：合格

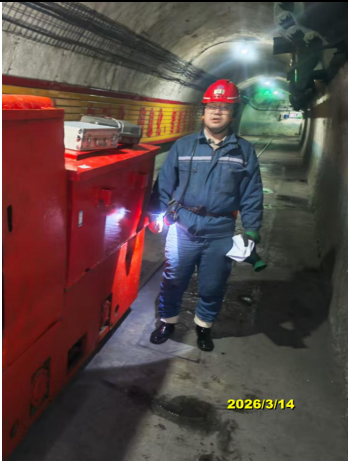
12	GX-B1517/26-7-26016	2026/6/1	综合判定：合格
