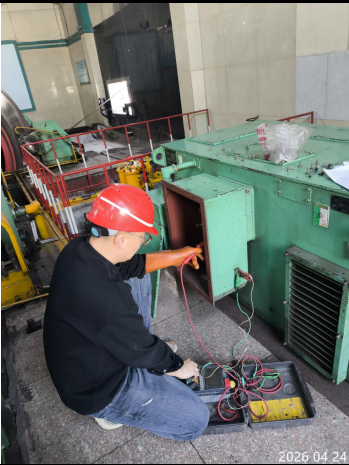
| 序号 | 报告编号 | 发布日期 | 结论 | 影像资料 |
|---|---|---|---|---|
| 264 | GX-B1323/26-6-26093~26098 | 2026/6/16 | 所检项目合格。 | |

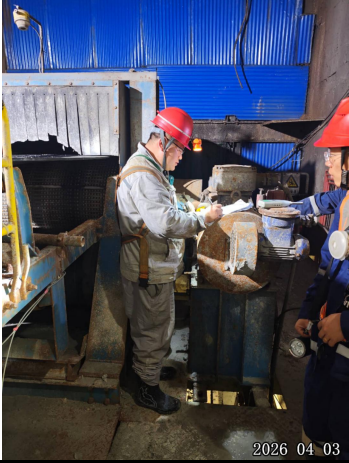
| 序号 | 报告编号 | 发布日期 | 结论 | 影像资料 |
|---|---|---|---|---|
| 265 | GX-B1422/23-6-26003 | 2026. 6. 15 | 综合判定：合格。 | |

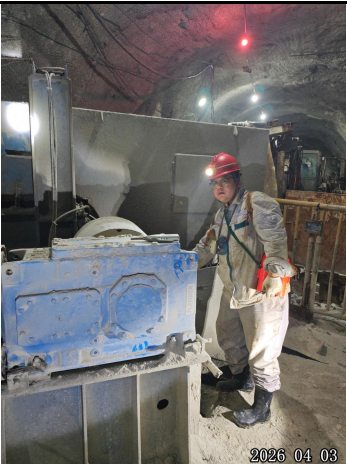
| 266 | GX-B1422/23-6-26004 | 2026. 6. 15 | 综合判定：合格。 | <p>2026 04 03</p> |

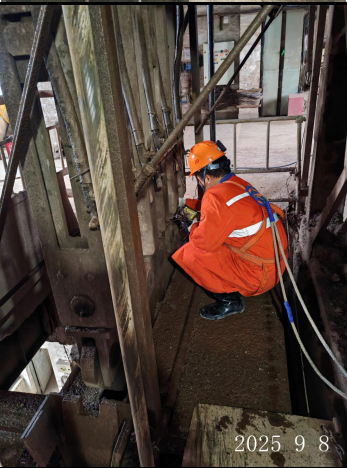
| 267 | GX-B1310/21-6-26085 替换 GX-B1310/21-6-25273 | 2026. 6. 9 | 符合标准要求 | <p>2025 9 8</p> |

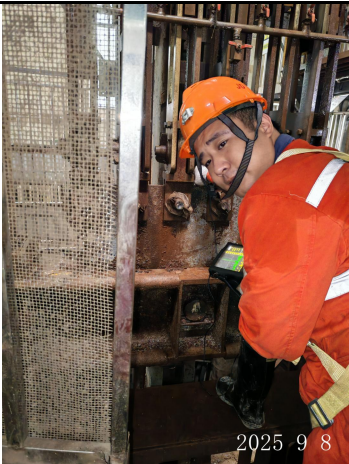
| 268 | GX-B1310/21-6-26086 替换 GX-B1310/21-6-25274 | 2026. 6. 9 | 符合标准要求 | A worker in an orange safety suit and helmet is working on a metal structure. The date 2025 9 8 is visible in the bottom right corner of the photo. |

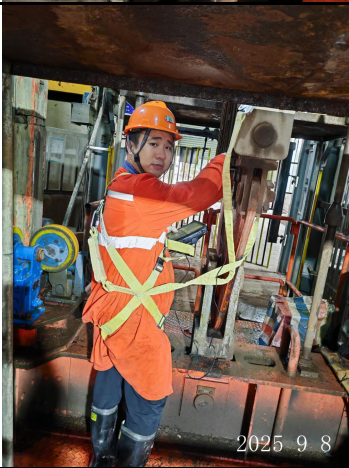
| 269 | GX-B1310/21-6-26087 替换 GX-B1310/21-6-25275 | 2026. 6. 9 | 符合标准要求 | A worker in an orange safety suit and helmet is working on a metal structure. The date 2025 9 8 is visible in the bottom right corner of the photo. |

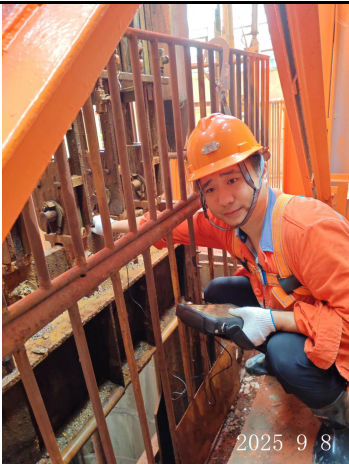
| 270 | GX-B1310/21-6-26088 替换 GX-B1310/21-6-25276 | 2026. 6. 9 | 符合标准要求 | |

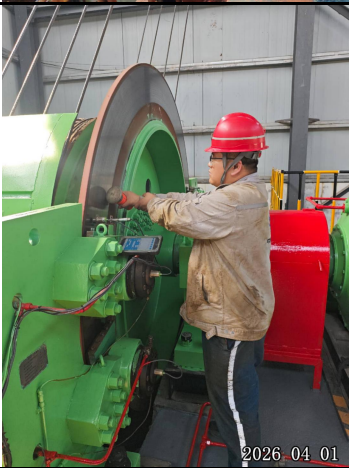
| 271 | GX-B1304/26-6-26018 | 2026. 6. 15 | 综合判定：合格。 | |

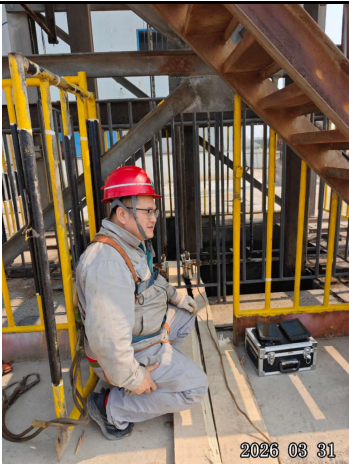
| 272 | GX-B1598/24-6-26194 | 2026. 6. 7 | 实测钢丝绳有效截面积损失百分比最大为4.13%，小于5%为正常。<br>。 | |

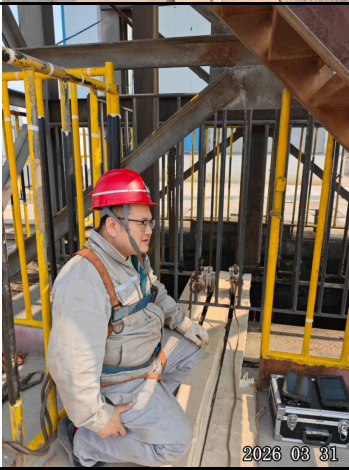
| 273 | GX-B1598/24-6-26195 | 2026. 6. 7 | 实测钢丝绳有效截面积损失百分比最大为4.31%，小于5%为正常。<br>。 | |

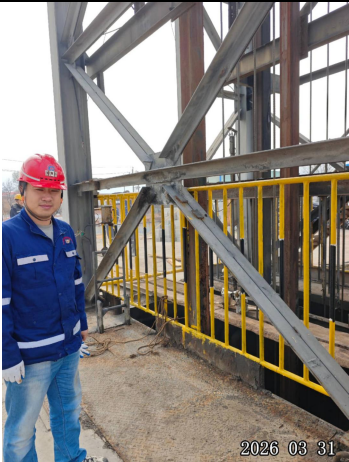
| 274 | GX-B1598/24-6-26196 | 2026. 6. 7 | 实测钢丝绳有效截面积损失百分比最大为3.96%，小于5%为正常。<br>。 | | |

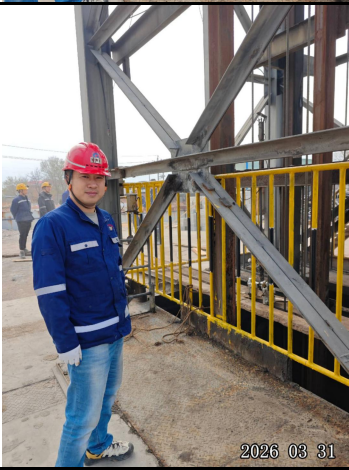
| 275 | GX-B1598/24-6-26197 | 2026. 6. 7 | 实测钢丝绳有效截面积损失百分比最大为4.38%，小于5%为正常。<br>。 | | |

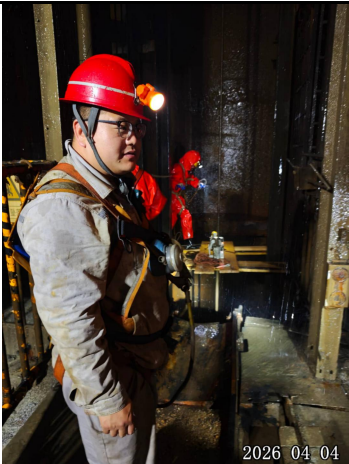
| 276 | GX-B1598/24-6-26198 | 2026. 6. 7 | 实测钢丝绳有效截面积损失百分比最大为1.45%，小于5%为正常。<br>。 | | |

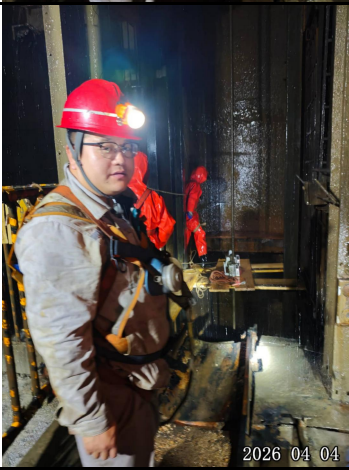
| 277 | GX-B1598/24-6-26199 | 2026. 6. 7 | 实测钢丝绳有效截面积损失百分比最大为1.40%，小于5%为正常。<br>。 | | |

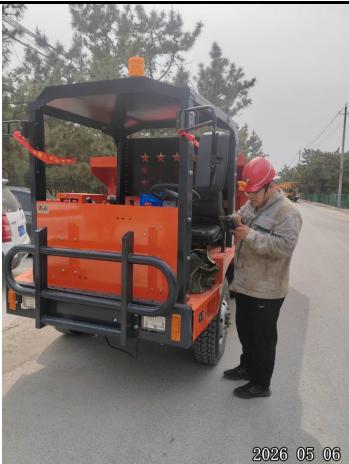
| 278 | GX-B1534/20-6-26042 | 2026. 6. 12 | 所检项目合格。 | |

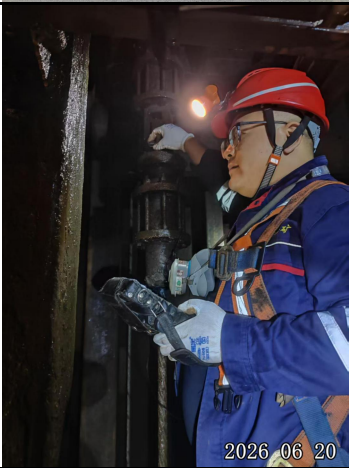
| 279 | GX-B1310/21-6-26113 | 2026. 6. 22 | 符合标准要求 | |

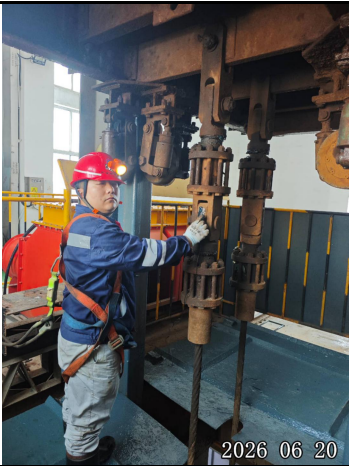
| 280 | GX-B1310/21-6-26114 | 2026. 6. 22 | 符合标准要求 | |

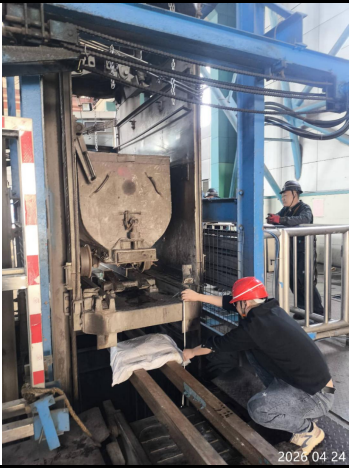
| 281 | GX-B1383/26-6-26001 | 2026. 6. 16 | 综合判定：不脱钩试验合格。 | |

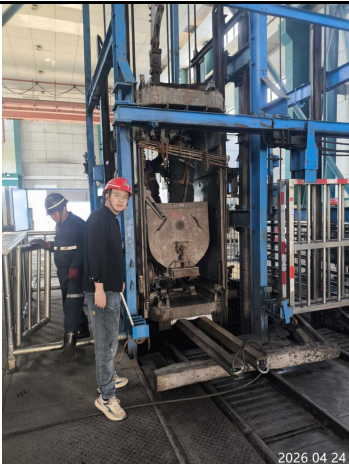
| 282 | GX-B1383/26-6-26002 | 2026. 6. 16 | 综合判定：不脱钩试验合格。 | |

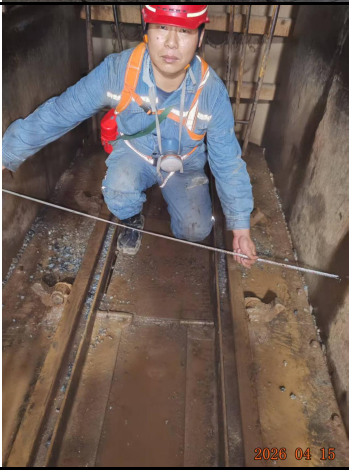
| 283 | GX-B1380/26-6-26026 | 2026. 6. 17 | 所检项目合格。 | |

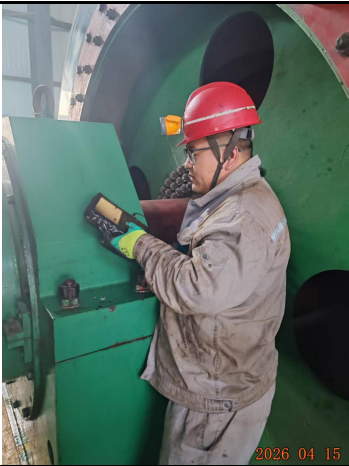
| 284 | GX-B1304/26-6-26017 | 2026. 6. 17 | 综合判定：合格。 | |

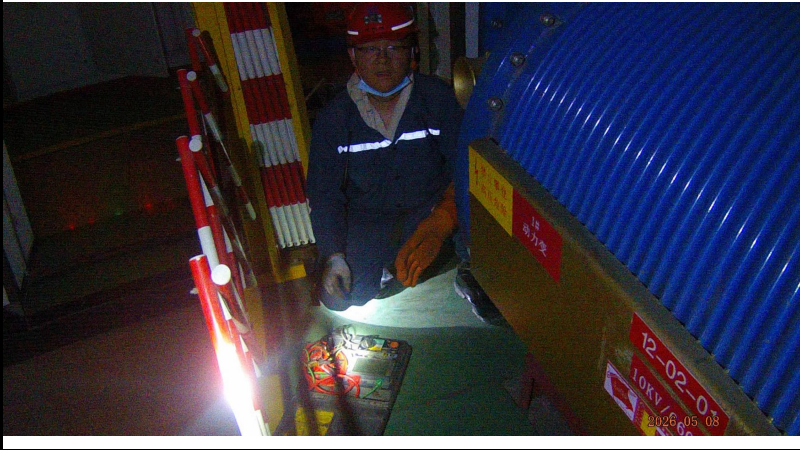
| 285 | GX-B1312/26-6-26118~25119 | 2026. 6. 16 | 本次共检电力变压器2台, 2台电力变压器所检项目合格。 | |

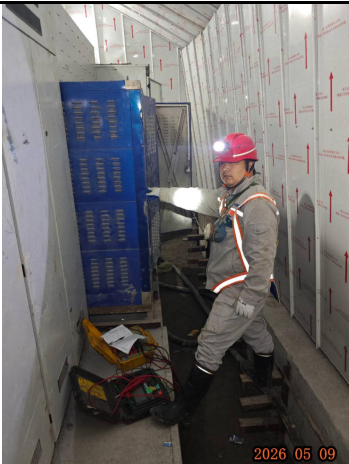
| 286 | GX-B1313/26-6-26189 | 2026. 6. 16 | 本次共检电力变压器1台，1台电力变压器所检项目合格。 | |

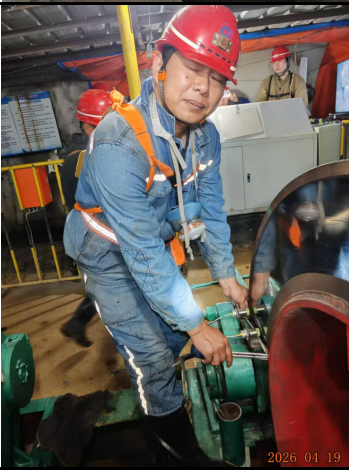
| 287 | GX-B1305/26-6-26029 | 2026/6/18 | 综合判定：合格。 | |

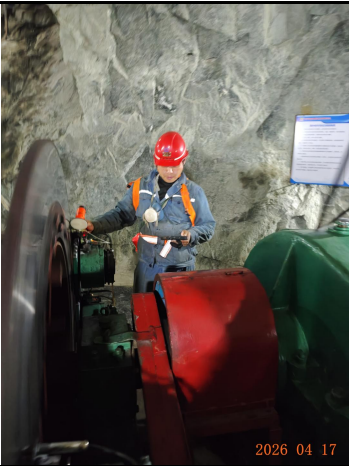
| 288 | GX-B1305/26-6-26033 | 2026/6/18 | 综合判定：合格。 | A worker wearing a blue uniform, a red helmet, and safety harness is operating a large red industrial machine in a tunnel. The machine has a large flywheel. A date stamp '2026 04 17' is visible in the bottom right corner of the image. |

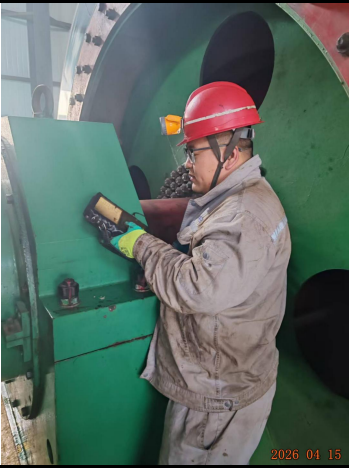
| 289 | GX-B1310/21-6-26079 | 2026/6/17 | 符合标准要求 | A worker wearing a grey uniform, a red helmet, and safety glasses is operating a large green industrial machine. The machine has a large flywheel. A date stamp '2026 04 15' is visible in the bottom right corner of the image. |

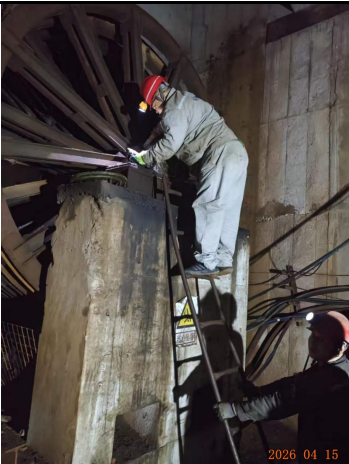
| 290 | GX-B1310/21-6-26080 | 2026/6/17 | 符合标准要求 | | | |

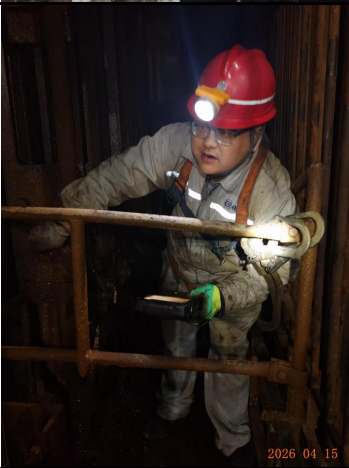
| 291 | GX-B1310/21-6-26081 | 2026/6/17 | 符合标准要求 | | | |

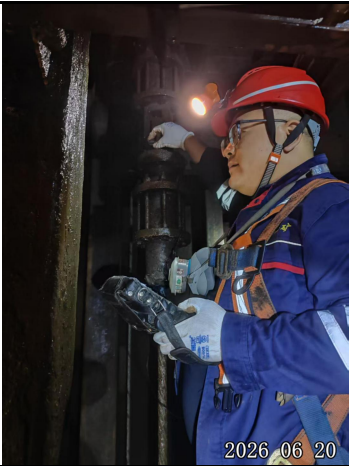
| 292 | GX-B1310/21-6-26113 | 2026. 6. 22 | 符合标准要求 | A worker wearing a blue uniform, red helmet, and safety harness is operating a device in a dark industrial setting. The date stamp '2026 06 20' is visible in the bottom right corner of the image. |

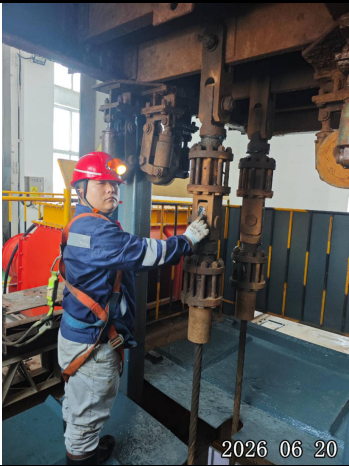
| 293 | GX-B1310/21-6-26114 | 2026. 6. 22 | 符合标准要求 | A worker wearing a blue uniform, red helmet, and safety harness is operating a device in a bright industrial setting. The date stamp '2026 06 20' is visible in the bottom right corner of the image. |

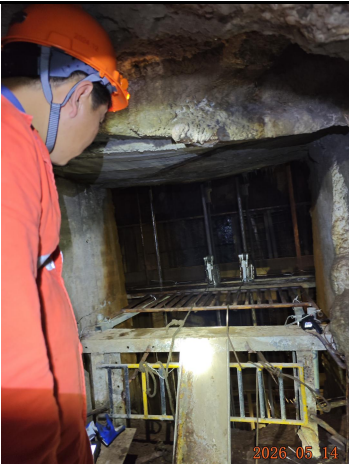
| 294 | GX-B1598/24-6-26206 | 2026. 6. 22 | 实测钢丝绳有效截面积损失百分比最大为4.71%，小于5%为正常。<br>。 | | |

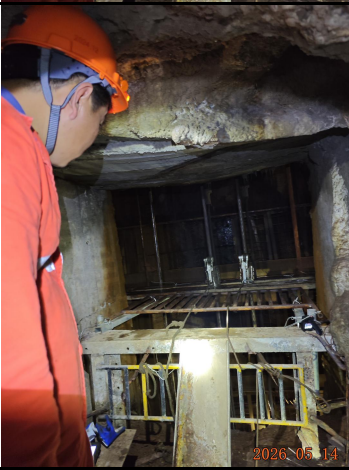
| 295 | GX-B1598/24-6-26207 | 2026. 6. 22 | 实测钢丝绳有效截面积损失百分比最大为4.79%，小于5%为正常。<br>。 | | |

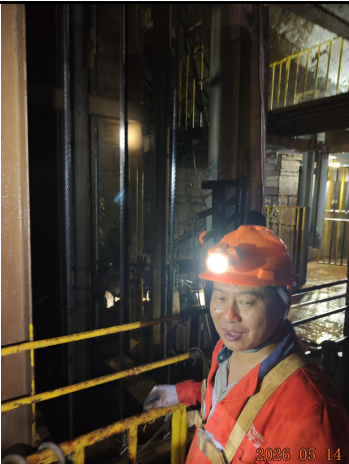
| 296 | GX-B1598/24-6-26208 | 2026. 6. 22 | 实测钢丝绳有效截面积损失百分比最大为4.28%，小于5%为正常。<br>。 | | | |

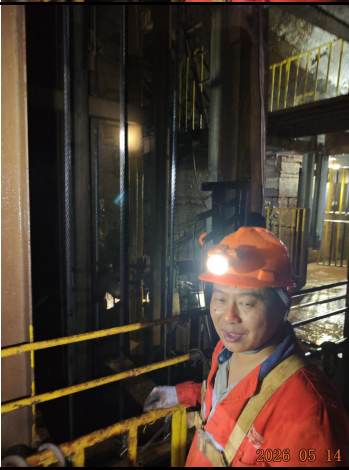
| 297 | GX-B1598/24-6-26209 | 2026. 6. 22 | 实测钢丝绳有效截面积损失百分比最大为4.42%，小于5%为正常。<br>。 | | | |

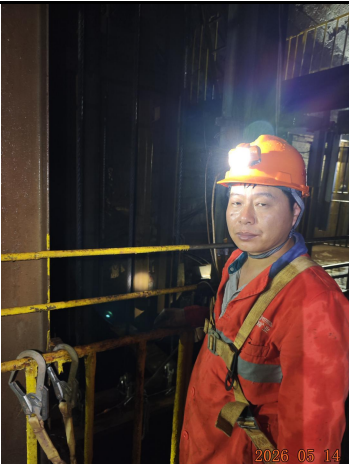
| 298 | GX-B1598/24-6-26210 | 2026. 6. 22 | 实测钢丝绳有效截面积损失百分比最大为4.18%，小于5%为正常。<br>。 | | |

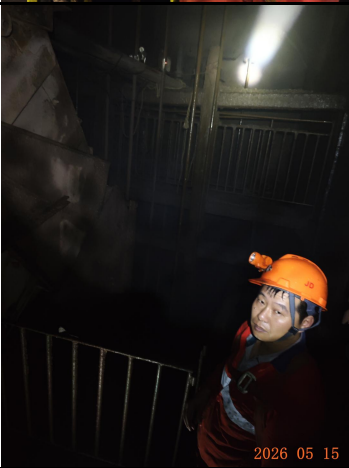
| 299 | GX-B1598/24-6-26211 | 2026. 6. 22 | 实测钢丝绳有效截面积损失百分比最大为2.28%，小于5%为正常。<br>。 | | |

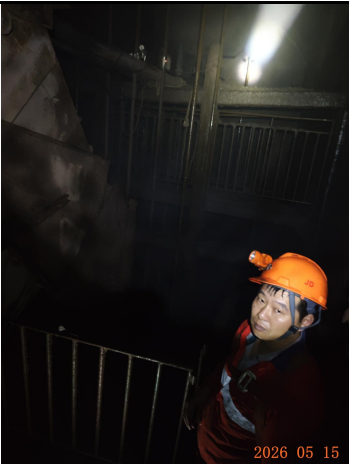
| 300 | GX-B1598/24-6-26212 | 2026. 6. 22 | 实测钢丝绳有效截面积损失百分比最大为2.31%，小于5%为正常。<br>。 | | |

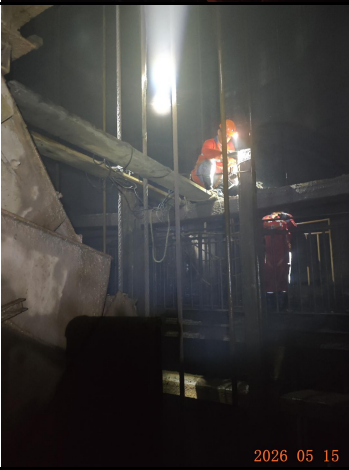
| 301 | GX-B1598/24-6-26213 | 2026. 6. 22 | 实测钢丝绳有效截面积损失百分比最大为2.34%，小于5%为正常。<br>。 | | |
