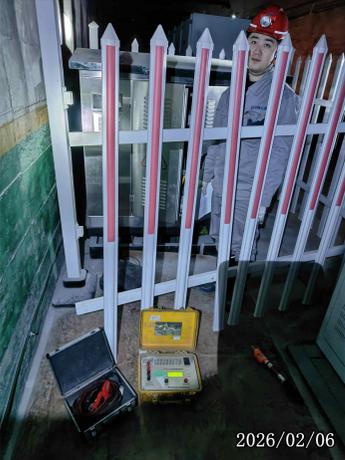
7	GX-B1313/26-2-26025~26026	2026/3/2	本次共检电力变压器2台，2台所检项目合格。 。

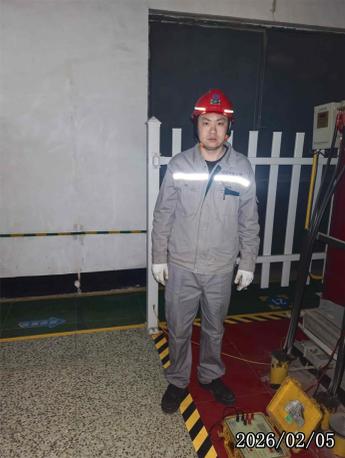
8	GX-B1313/26-2-26022~26024	2026/3/2	本次共检电力变压器3台，3台所检项目合格。 。

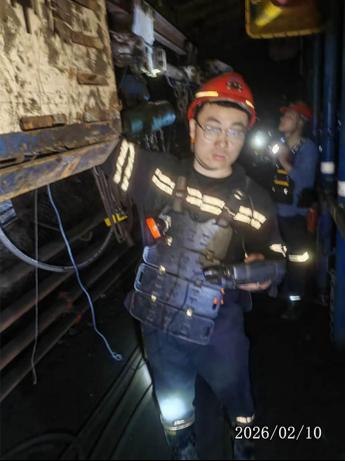
11	GX-B1310/21-2-26055	2026/3/2	符合标准要求。

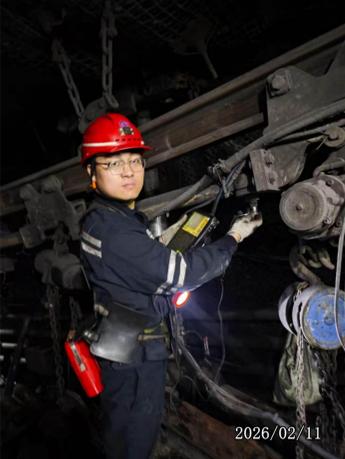
12	GX-B1310/21-2-26056	2026/3/2	符合标准要求。

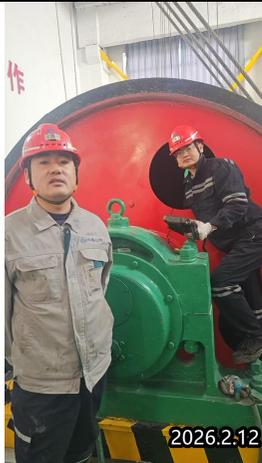
53	GX-B1310/21-2-26076	2026. 3. 3	符合标准要求。

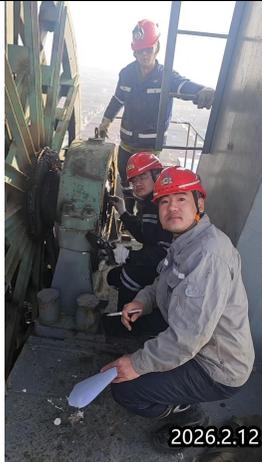
54	GX-B1310/21-2-26077	2026. 3. 3	符合标准要求。

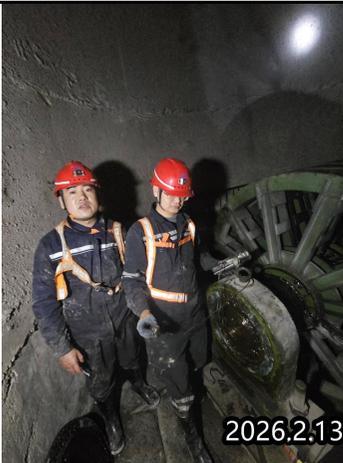
67	GX-B1310/21-2-26090	2026. 3. 3	符合标准要求。

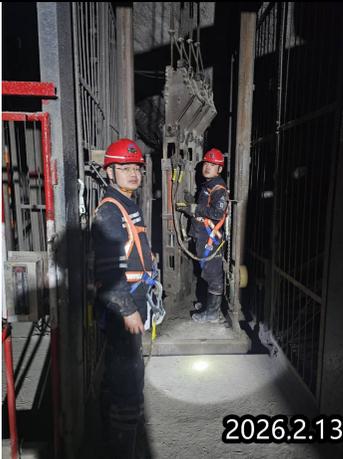
<p>2026.2.13</p>	
68	GX-B1310/21-2-26091	2026. 3. 3	符合标准要求。
