序号	报告编号	发布日期	结论	影像资料
1	GX-B1382/26-6-26001	2026/3/2	综合判定合格

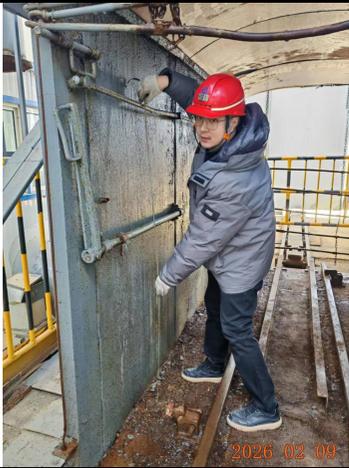
2	GX-B1380/26-6-26001	2026/3/2	所检项目合格

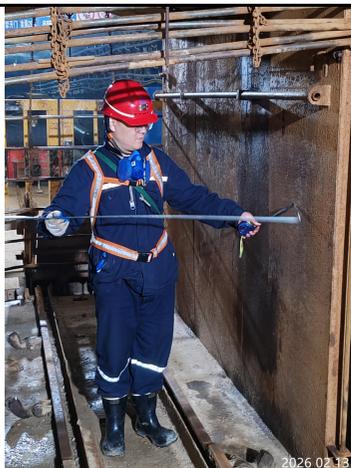
3	GX-B1380/26-6-26004	2026/3/2	所检项目合格

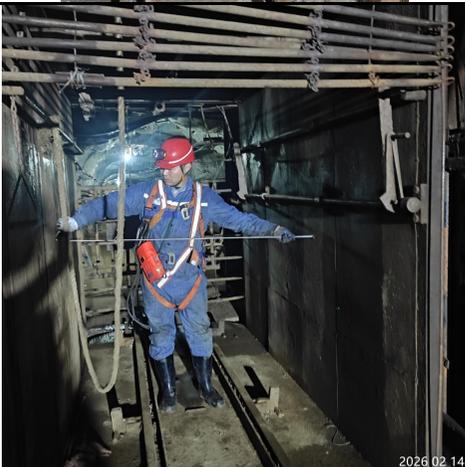
<p>2026.02.13</p>
4	GX-B1380/26-6-26005	2026/3/2	所检项目合格

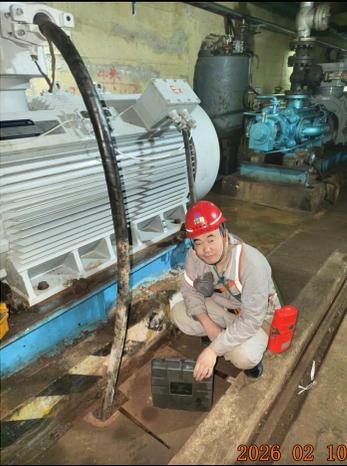
5	GX-B1324/26-6-26001~26004	2026/3/2	所检项目合格

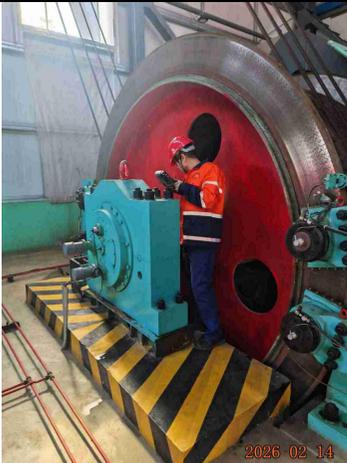
<p>2026 02 10</p>
6	GX-B1310/21-6-26004	2026年3月2日	符合标准要求

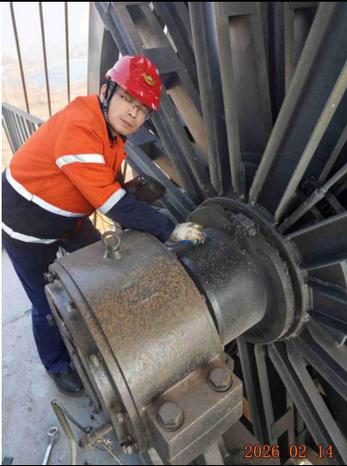
7	GX-B1310/21-6-26005	2026年3月2日	符合标准要求

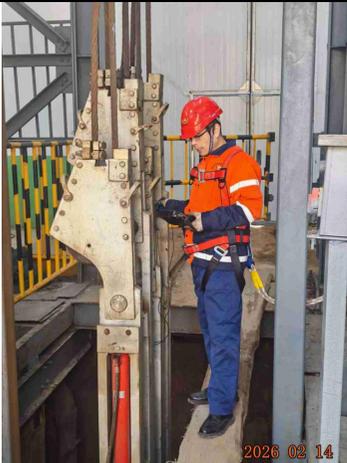
<p>2026 02 14</p>
8	GX-B1310/21-6-26006	2026年3月2日	符合标准要求

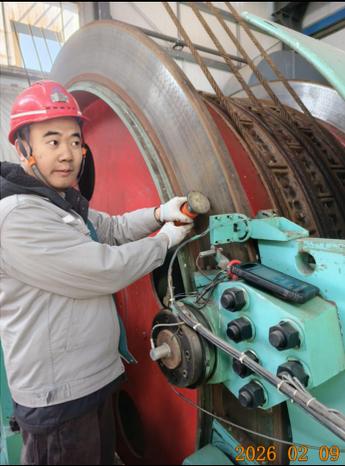
9	GX-B1304/26-6-26010	2026/3/2	综合判定合格

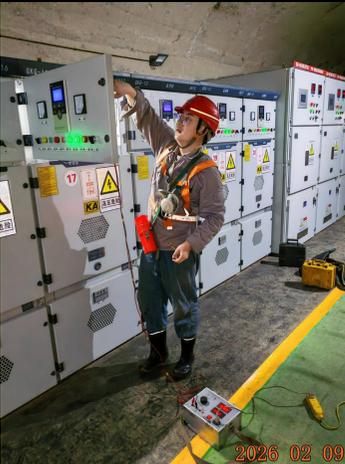
36	GX-B1451/26-6-26044~26048	2026年3月3日	本次共检高压开关柜5台,5台高压开关柜所检项目合格。

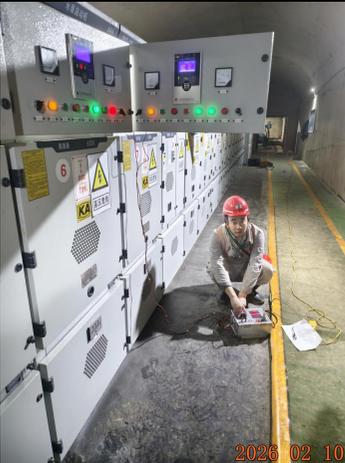
37	GX-B1451/26-6-26049~26061	2026年3月3日	本次共检高压开关柜 13台, 13台高压开关柜 所检项目合格。

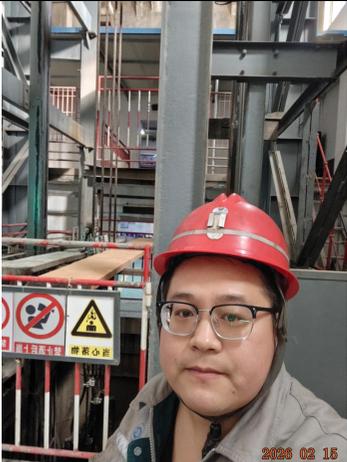
A worker in a red hard hat and blue overalls is operating a large green industrial machine with a large spool of wire. The date stamp in the bottom right corner of the image is 2026 02 12.
40	GX-B1598/24-6-26041	2026年3月3日	实测钢丝绳有效截面积损失百分比最大为2.62%，小于5%为正常。

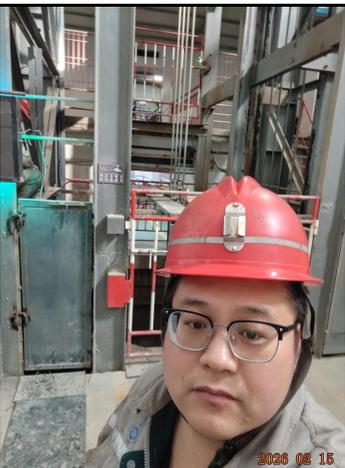
41	GX-B1598/24-6-26042	2026年3月3日	实测钢丝绳有效截面积损失百分比最大为2.70%，小于5%为正常。

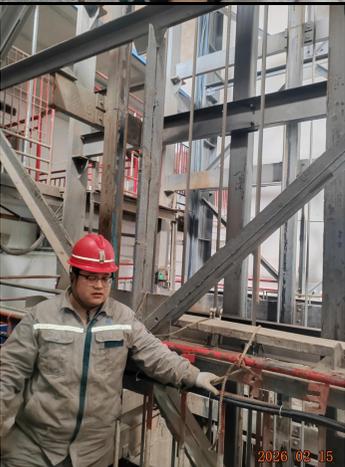
42	GX-B1598/24-6-26043	2026年3月3日	实测钢丝绳有效截面积损失百分比最大为2.63%，小于5%为正常。

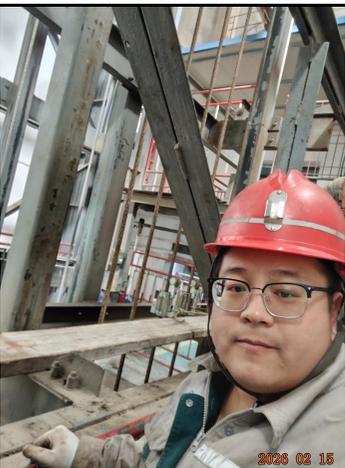
43	GX-B1598/24-6-26044	2026年3月3日	实测钢丝绳有效截面积损失百分比最大为2.76%，小于5%为正常。

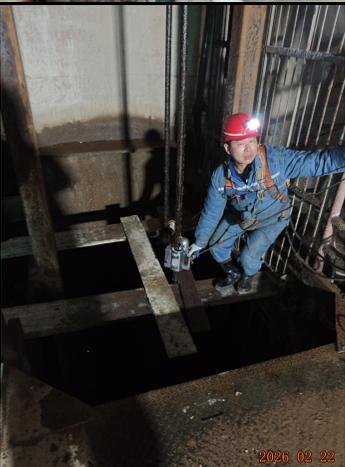
44	GX-B1598/24-6-26045	2026年3月3日	实测钢丝绳有效截面积损失百分比最大为2.34%，小于5%为正常。

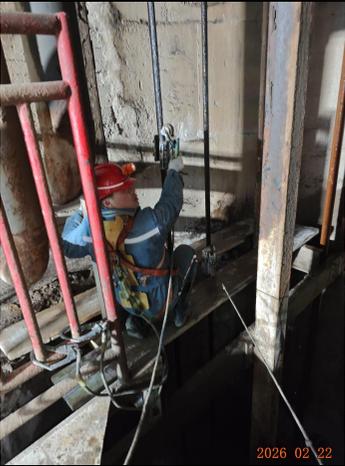
45	GX-B1598/24-6-26046	2026年3月3日	实测钢丝绳有效截面积损失百分比最大为2.39%，小于5%为正常。

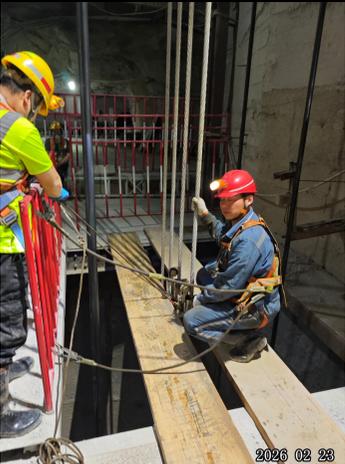
46	GX-B1598/24-6-26047	2026年3月3日	实测钢丝绳有效截面积损失百分比最大为1.91%，小于5%为正常。

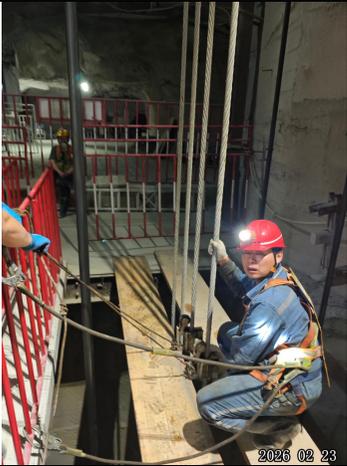
47	GX-B1598/24-6-26048	2026年3月3日	实测钢丝绳有效截面积损失百分比最大为1.71%，小于5%为正常。

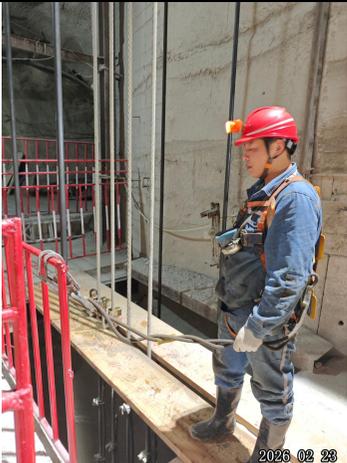
48	GX-B1598/24-6-26049	2026年3月3日	实测钢丝绳有效截面积损失百分比最大为1.41%，小于5%为正常。

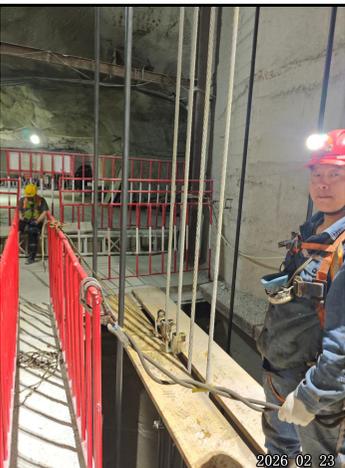
49	GX-B1598/24-6-26050	2026年3月3日	实测钢丝绳有效截面积损失百分比最大为1.78%，小于5%为正常。

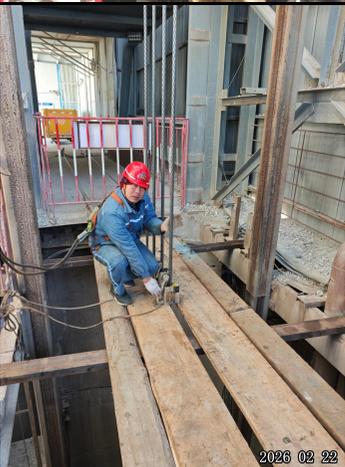
<p>2026 02 23</p>
50	GX-B1598/24-6-26035	2026年3月3日	实测钢丝绳有效截面积损失百分比最大为2.91%，小于5%为正常。

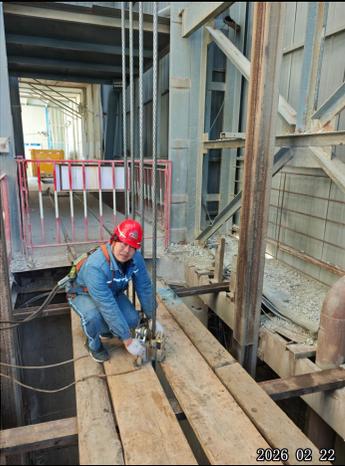
51	GX-B1598/24-6-26036	2026年3月3日	实测钢丝绳有效截面积损失百分比最大为2.23%，小于5%为正常。

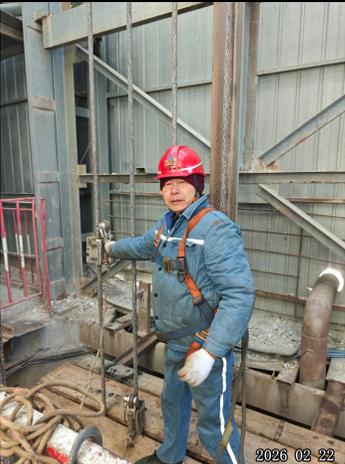
<p>2026 02 22</p>
52	GX-B1598/24-6-26037	2026年3月3日	实测钢丝绳有效截面积损失百分比最大为3.28%，小于5%为正常。

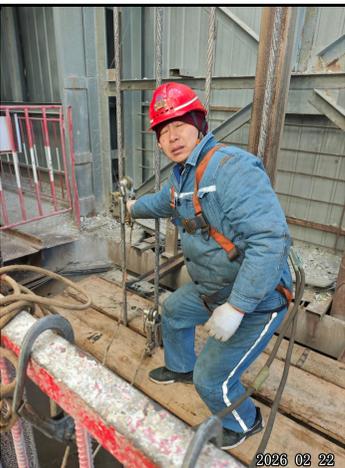
53	GX-B1598/24-6-26038	2026年3月3日	实测钢丝绳有效截面积损失百分比最大为2.66%，小于5%为正常。

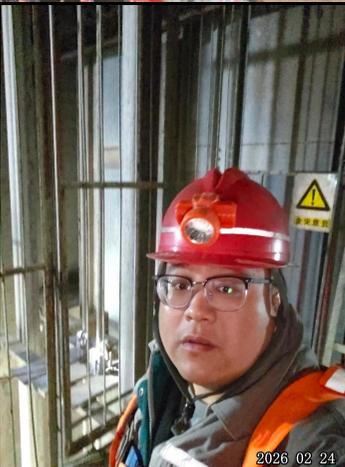
A worker wearing a blue work uniform and a red safety helmet is positioned on a wooden platform or scaffolding. He is looking towards the camera while working on a steel structure. The background shows industrial equipment and metal beams. A timestamp '2026 02 22' is visible in the bottom right corner of the photo.
54	GX-B1598/24-6-26039	2026年3月3日	实测钢丝绳有效截面积损失百分比最大为2.72%，小于5%为正常。

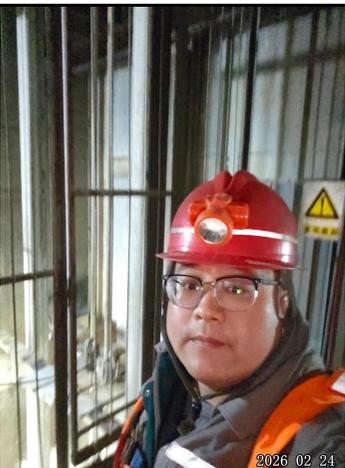
55	GX-B1598/24-6-26040	2026年3月3日	实测钢丝绳有效截面积损失百分比最大为2.19%，小于5%为正常。

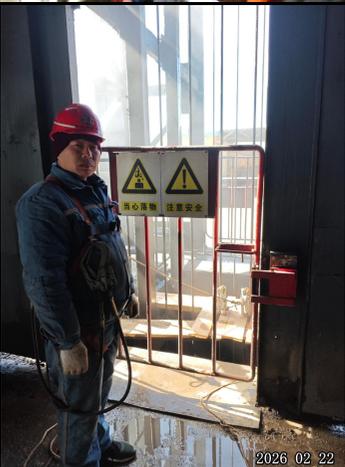
56	GX-B1598/24-6-26023	2026年3月4日	实测钢丝绳有效截面积损失百分比最大为0.69%，小于5%为正常。

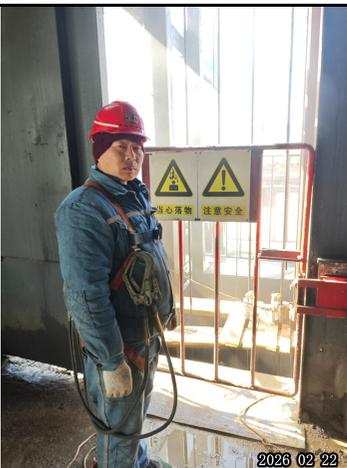
57	GX-B1598/24-6-26024	2026年3月4日	实测钢丝绳有效截面积损失百分比最大为0.84%，小于5%为正常。

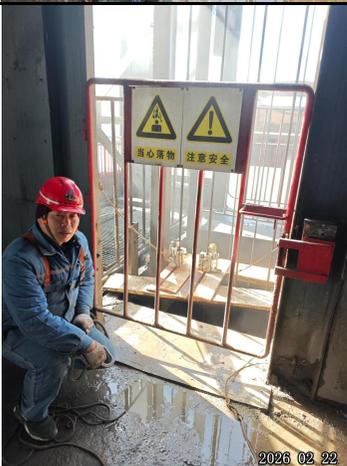
58	GX-B1598/24-6-26025	2026年3月4日	实测钢丝绳有效截面积损失百分比最大为0.88%，小于5%为正常。

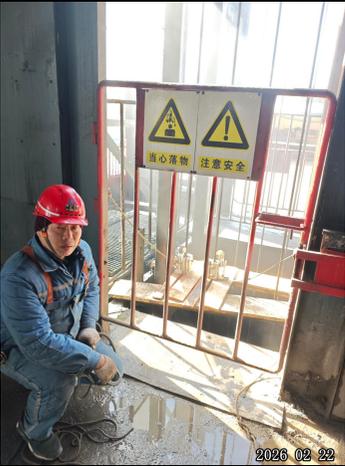
59	GX-B1598/24-6-26026	2026年3月4日	实测钢丝绳有效截面积损失百分比最大为0.80%，小于5%为正常。

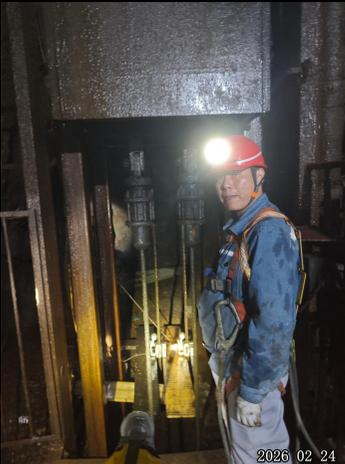
60	GX-B1598/24-6-26027	2026年3月4日	实测钢丝绳有效截面积损失百分比最大为2.17%，小于5%为正常。

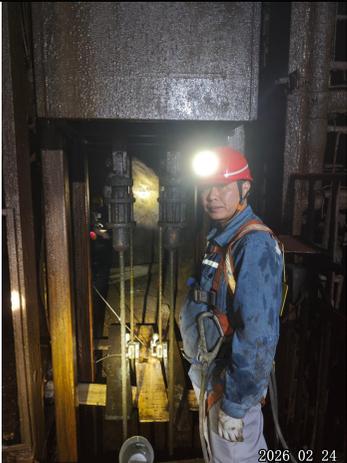
61	GX-B1598/24-6-26028	2026年3月4日	实测钢丝绳有效截面积损失百分比最大为1.87%，小于5%为正常。

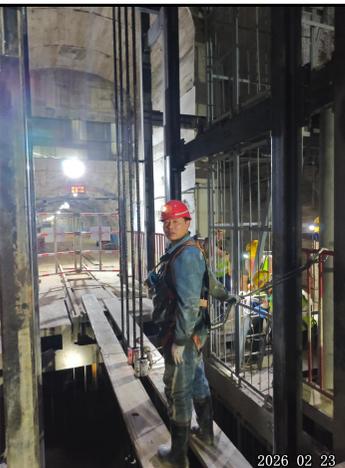
65	GX-B1598/24-6-26030	2026/3/4	实测钢丝绳有效截面积损失百分比最大为1.77%，小于5%为正常。 。

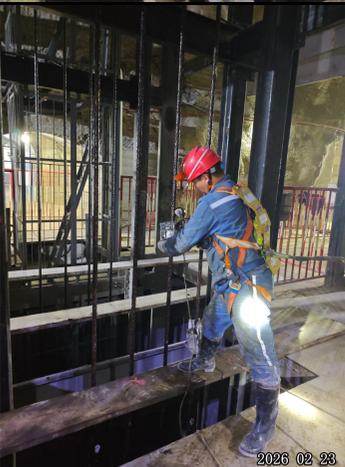
<p>2026 02 23</p>
66	GX-B1598/24-6-26031	2026/3/4	实测钢丝绳有效截面积损失百分比最大为1.72%，小于5%为正常。 。

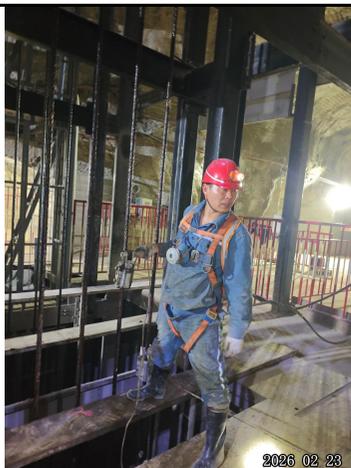
67	GX-B1598/24-6-26032	2026/3/4	实测钢丝绳有效截面积损失百分比最大为1.64%，小于5%为正常。

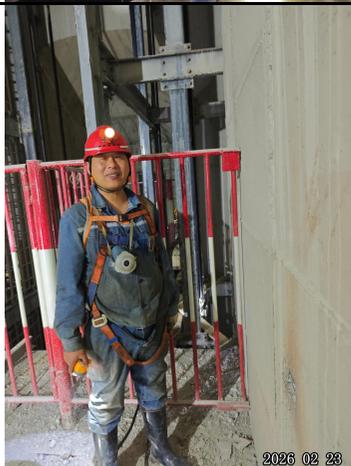
<p>2026 02 23</p>
68	GX-B1598/24-6-26033	2026/3/4	实测钢丝绳有效截面积损失百分比最大为4.33%，小于5%为正常。

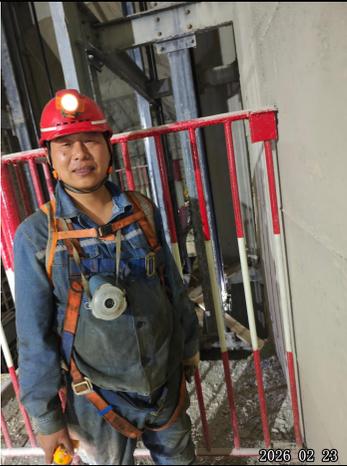
69	GX-B1598/24-6-26034	2026/3/4	实测钢丝绳有效截面积损失百分比最大为4.61%，小于5%为正常。

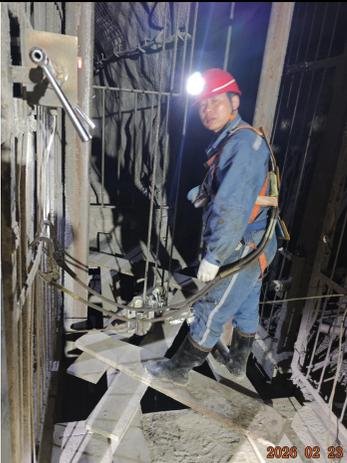
A photograph of a worker wearing a red hard hat with a headlamp, a blue long-sleeved shirt, and a safety harness. The worker is standing on a metal structure, possibly a lift or a platform, with a red safety railing. The background shows some industrial equipment. A timestamp "2026 02 23" is visible in the bottom right corner of the photo.
70	GX-B1598/24-6-26053	2026/3/4	实测钢丝绳有效截面积损失百分比最大为3.12%，小于5%为正常。

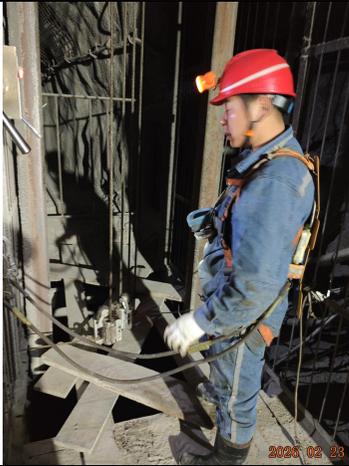
71	GX-B1598/24-6-26054	2026/3/4	实测钢丝绳有效截面积损失百分比最大为2.63%，小于5%为正常。 。

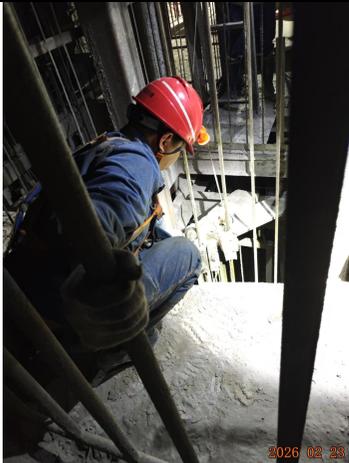
A photograph showing a worker in a red safety helmet and blue work clothes standing on a metal platform or scaffolding. The worker is looking towards the right side of the frame. The background shows a complex network of steel beams and structures, likely part of a large-scale construction or industrial project. A timestamp '2026 03 23' is visible in the bottom right corner of the image.
72	GX-B1598/24-6-26055	2026/3/4	实测钢丝绳有效截面积损失百分比最大为2.86%，小于5%为正常。 。

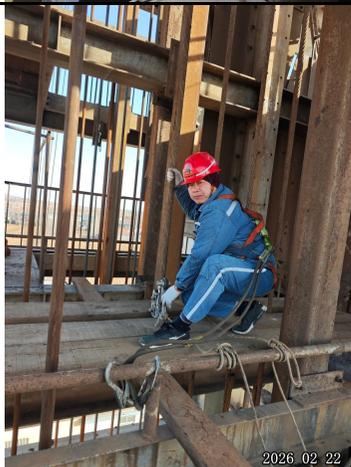
76	GX-B1598/24-6-26059	2026/3/4	实测钢丝绳有效截面积损失百分比最大为1.45%，小于5%为正常。 。

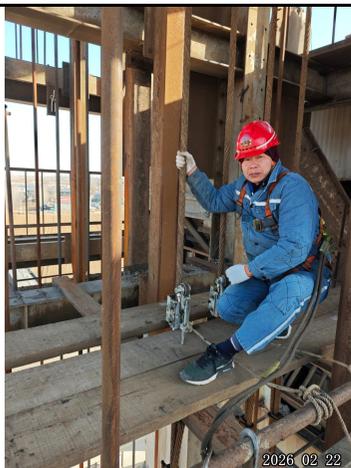
77	GX-B1598/24-6-26060	2026/3/4	实测钢丝绳有效截面积损失百分比最大为1.59%，小于5%为正常。 。

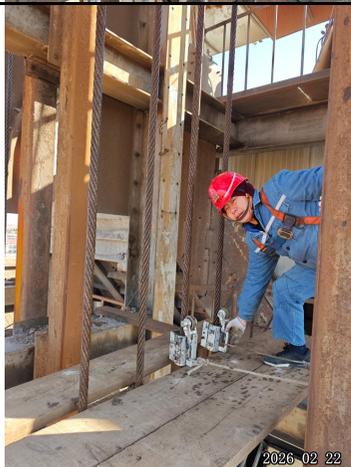
<p>2026 02 22</p>
78	GX-B1598/24-6-26061	2026/3/4	实测钢丝绳有效截面积损失百分比最大为1.53%，小于5%为正常。 。

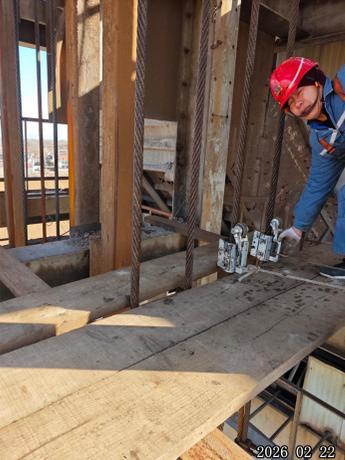
79	GX-B1598/24-6-26062	2026/3/4	实测钢丝绳有效截面积损失百分比最大为1.87%，小于5%为正常。

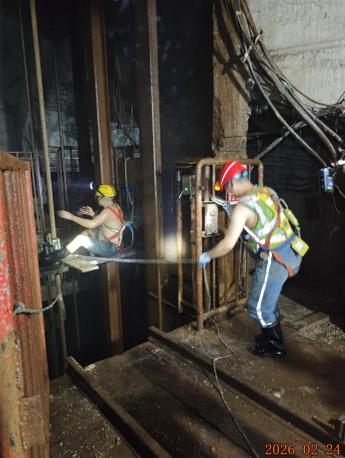
80	GX-B1598/24-6-26063	2026/3/4	实测钢丝绳有效截面积损失百分比最大为2.86%，小于5%为正常。

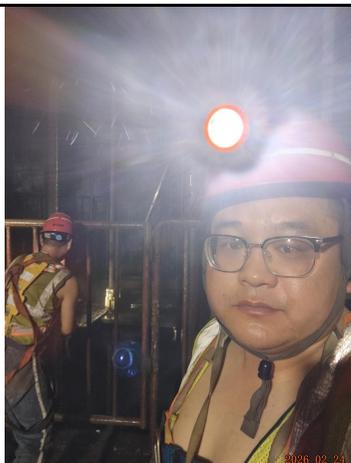
81	GX-B1598/24-6-26064	2026/3/4	实测钢丝绳有效截面积 损失百分比最大为 2.98%，小于5%为正常。
